1960 Corvette Outer door button adjustment

Dave Zuberer

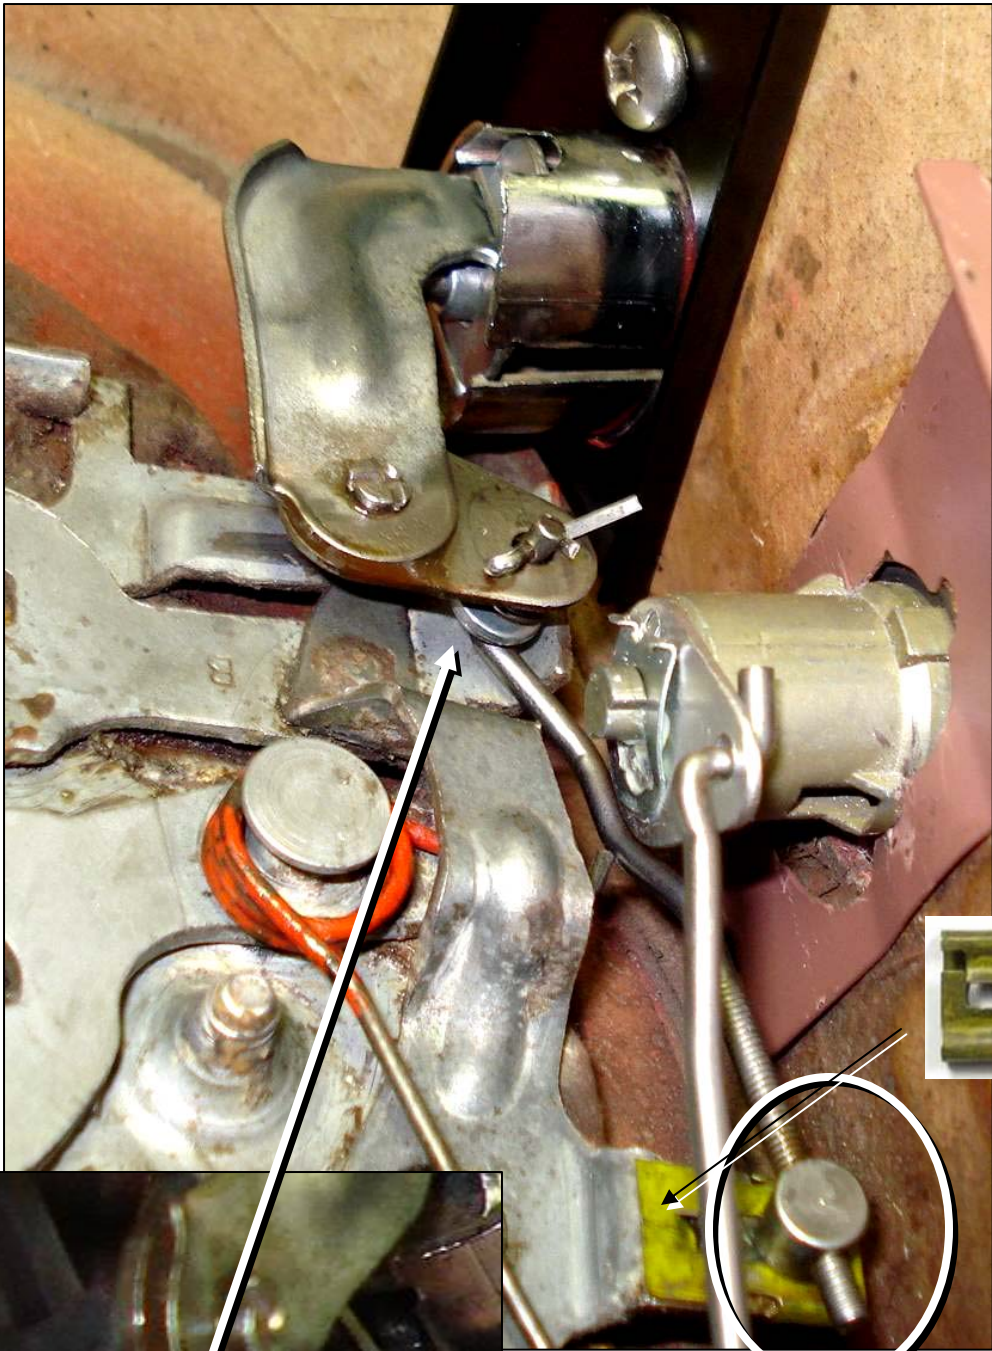
Driver-side latch mechanism

**Door
Lock Rod
Clip**

**Threaded pivot
adjustment**

Spring and washer

The adjustment that corrected the problem is shown in the attached photos. The door button rod pushes on a “pad” that activates the Door handle push button rod with an adjustable pivot. Adjusting that pivot corrected the “hanging” of the latch when opening from the outside.

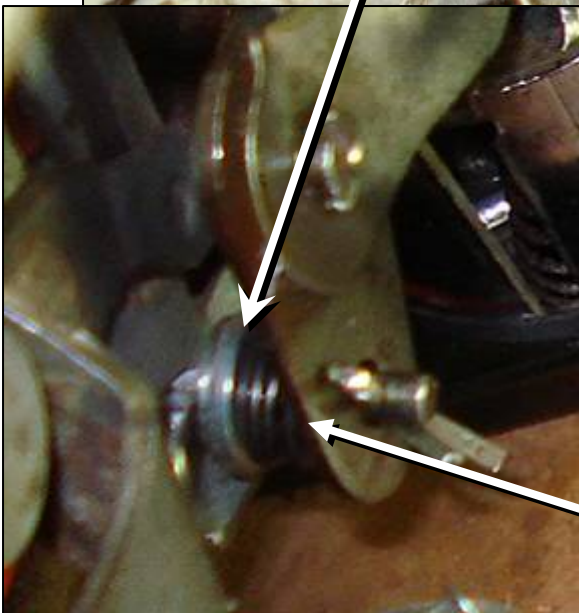
This rod pushes on the pad that actuates the Door handle push button rod

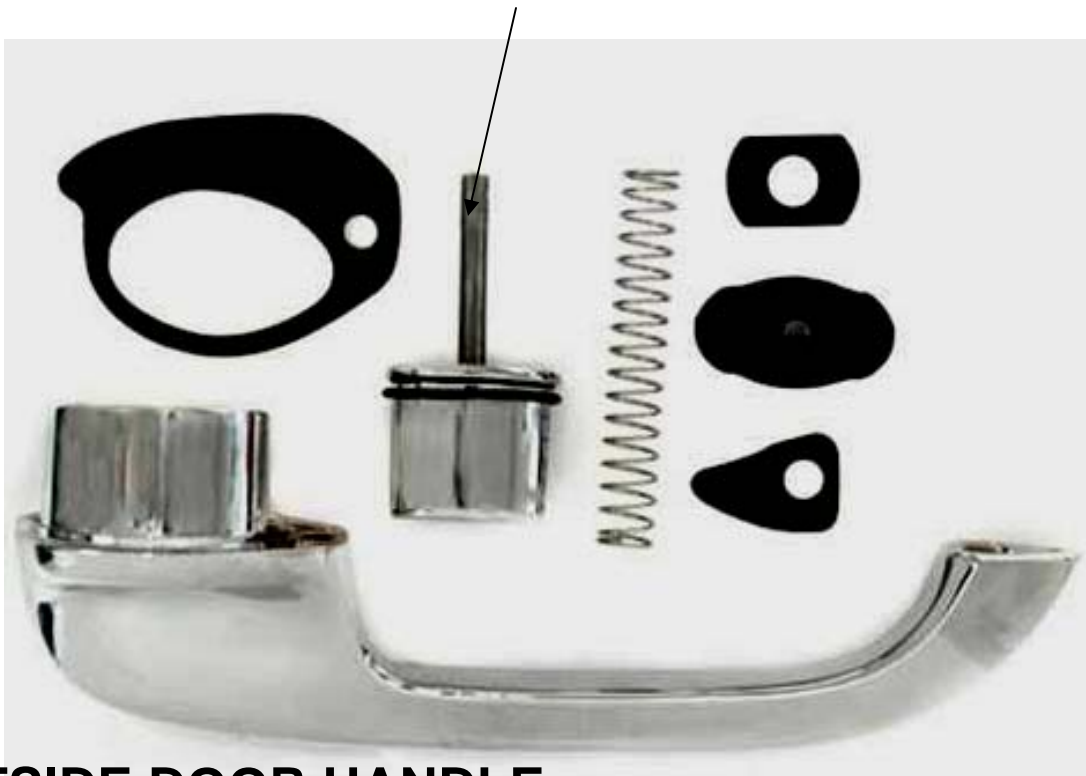
OUTSIDE DOOR HANDLE
Paragon Number: 6681K

Button rod pushes against this pad to actuate the door handle push button rod.
