Dave Zuberer

## Glove Box – 1965 Coupe

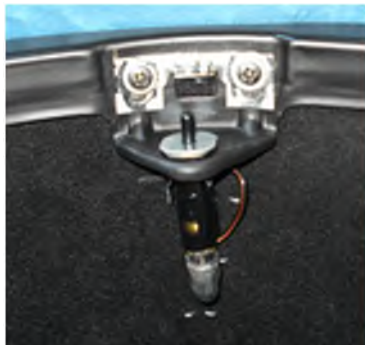
Toward the open slit in the side of the switch

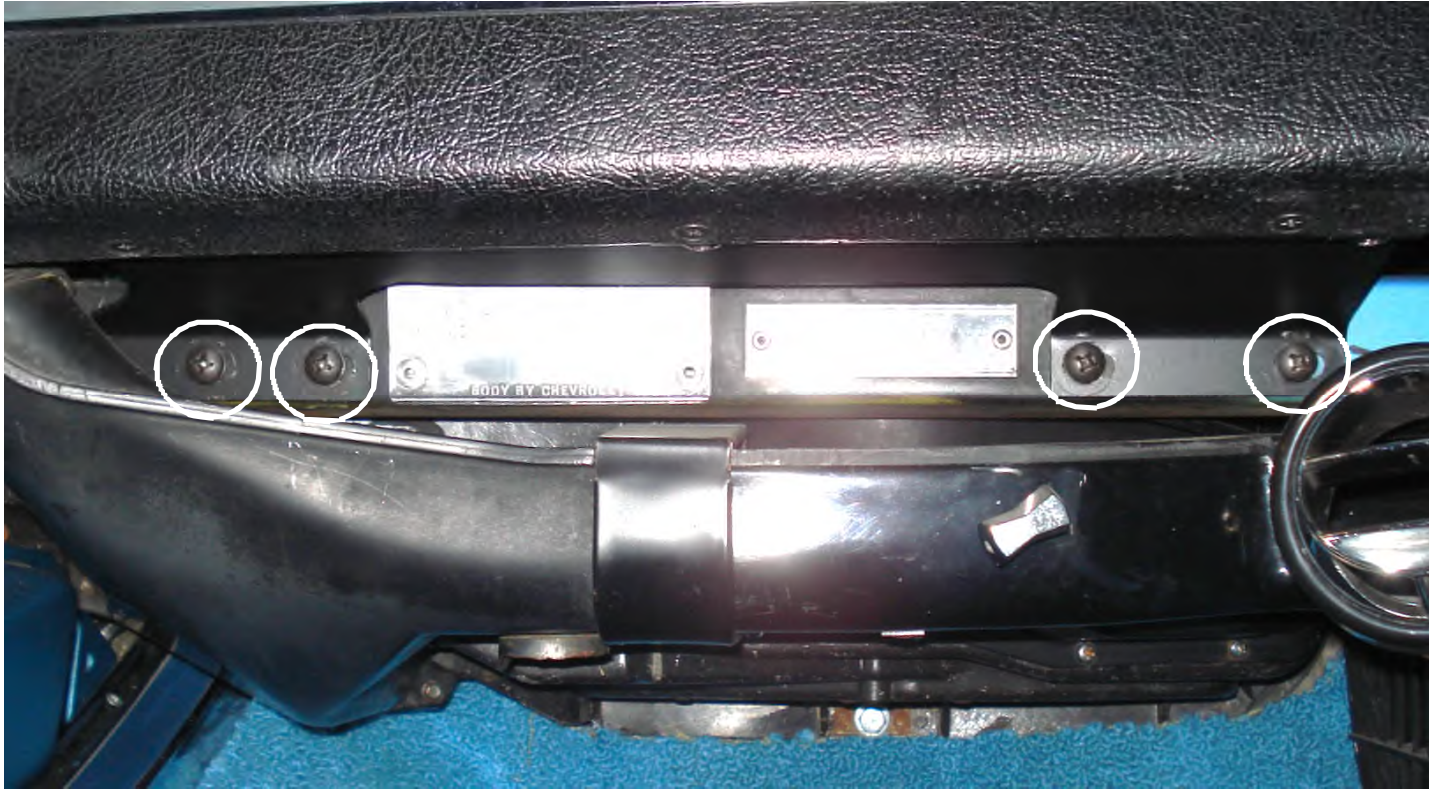
These 4 screws mount the glove-box assembly to the “z-bar”. If you remove the frame screws in the previous photo, I believe you can remove the whole glove box assembly (liner included) as one piece. You will have to disconnect the glove-box lamp switch to pull the box.
