01.29.04

This is a task I was dreading. The headlight motor rebuild. I could send them off for \$128 per motor, or do it myself. I decided to do it myself after Gary C from Castle Rock...

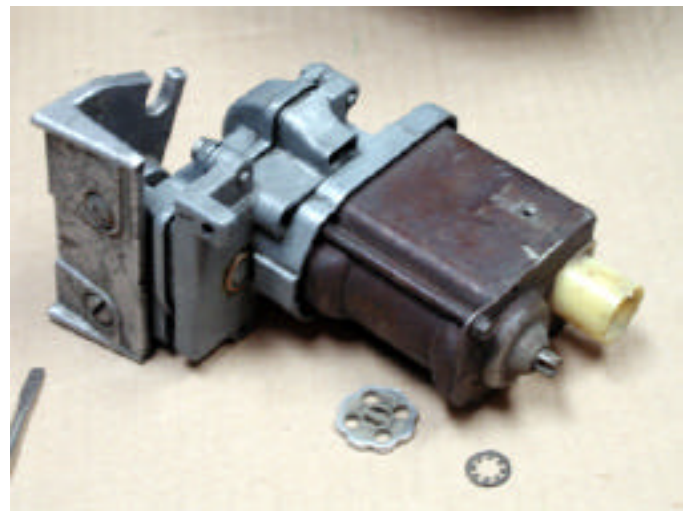
...Colorado sent me a set of instructions via the web. I met him on the Corvette Forum. We started out by checking on the condition of the electric motor. First remove the retaining ring from the rotating knob as shown in the previous picture.

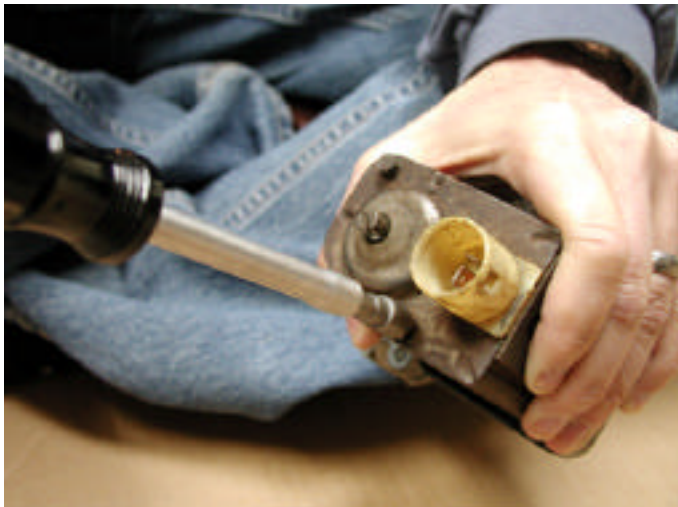
Next, remove the two bolts that hold the electric motor casing together.

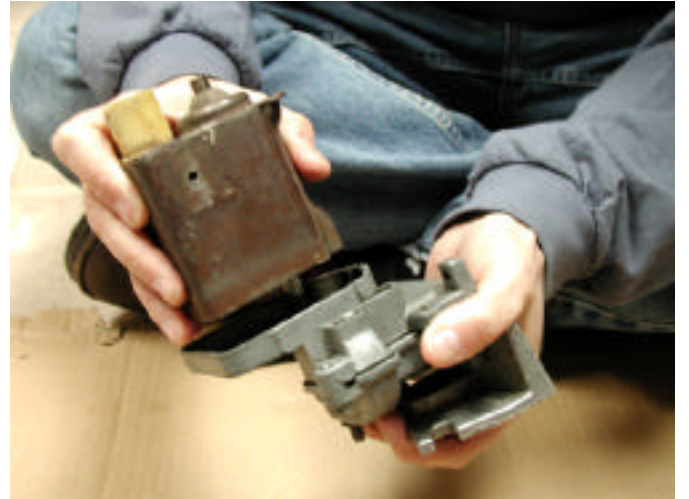
Pull the two sections apart. You may want to do this the opposite of how I show it here in case your "junk" wants to fall out. In my case it didn't, but it could have I suppose.

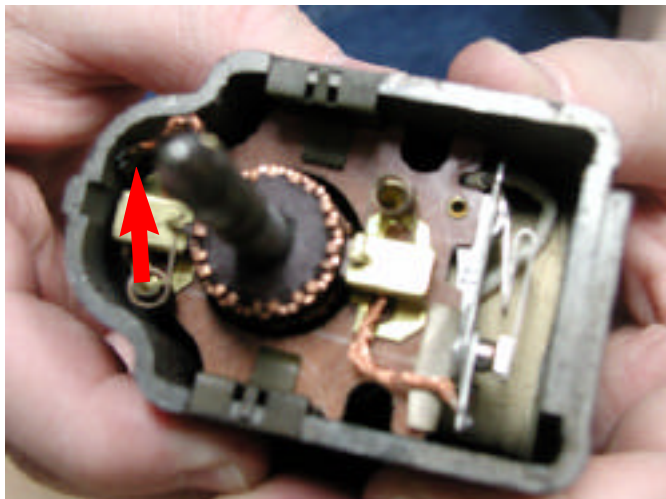
Here is a semi blurry shot of what you can expect to find inside. The arrow points to the brush that is soldered to the casing. Be careful not to break it off when removing the motor and other parts.

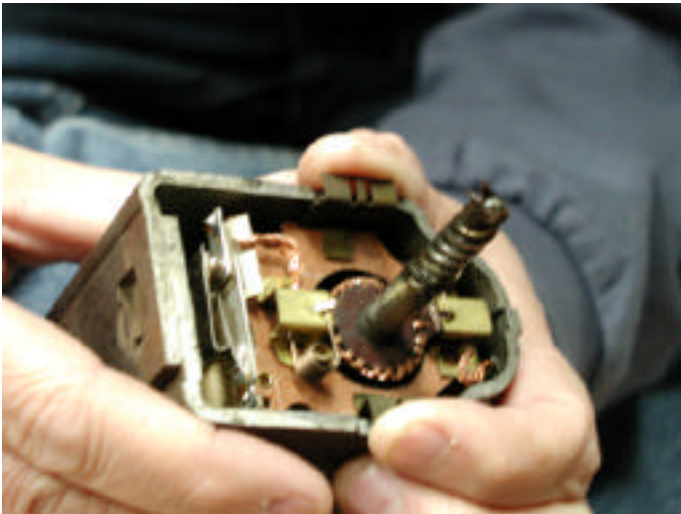
Remove the brush assembly by pressing up on the retaining clips as shown. Remember the one against the curved side is soldered to the housing.

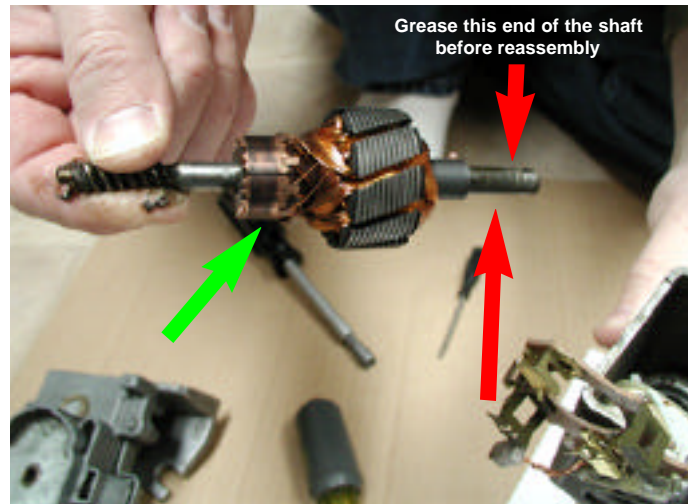
The reason for sanding the spindle is that corrosion may cause it to pull out the bearing in the bottom of the housing. And it is really hard to get it back in if it comes out. Notice the corrosion on the copper contacts (grn arrow)

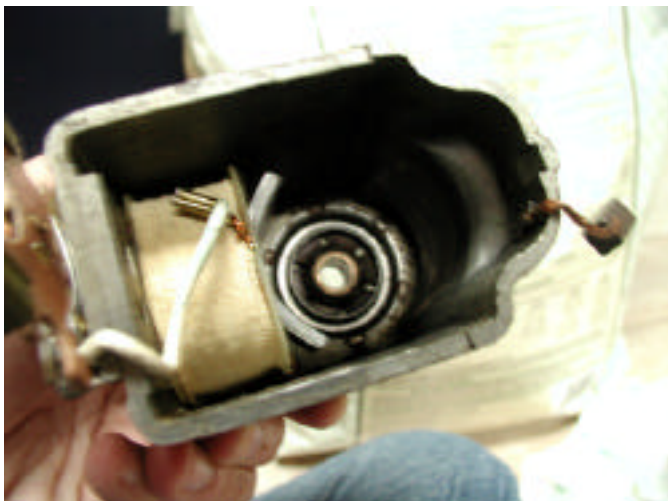
Here is what is left inside the housing. If the part shown here is bad, you can start crying aloud. Nobody will think any less of you. GM no longer makes this part.

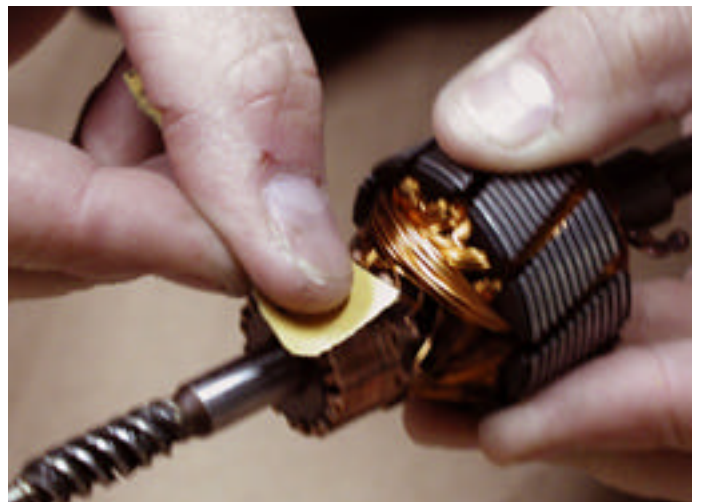
With really fine sand paper (I used 2000 grit) sand away any tarnish or corrosion on the contact area of the motor.

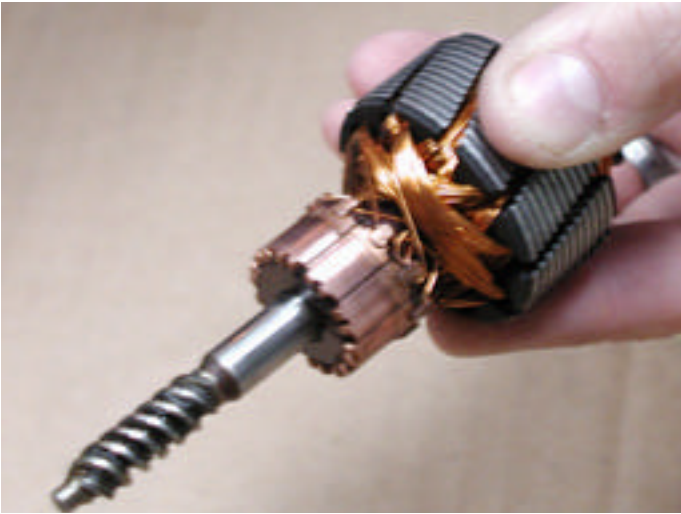
Oooooohhhhhh.... Aaaaahhhhhh

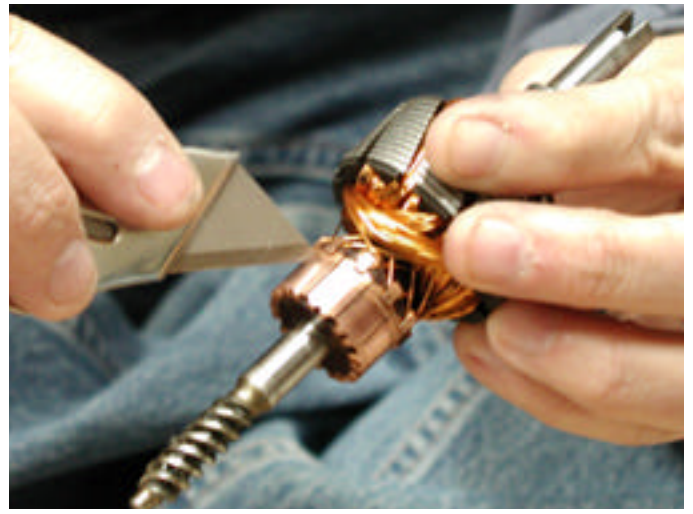
Then clean any corrosion build up out of the scored lines on the contact area of the motor.

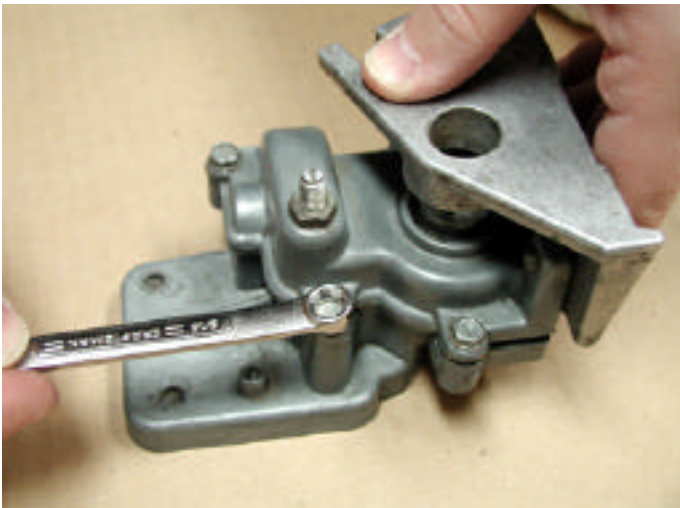
Next remove the four bolts that hold the gear section together. Most of the problems you are going to have are in here. But fear not... it is so easy it makes you want to file charges against those guyz charging \$128 per motor to rebuild them.

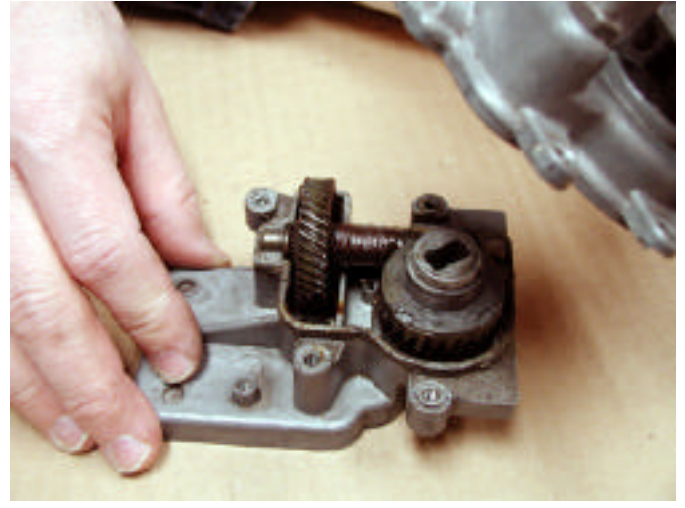
Wa La! The gunk covered gears are now visible to the naked (or clothed) eye.

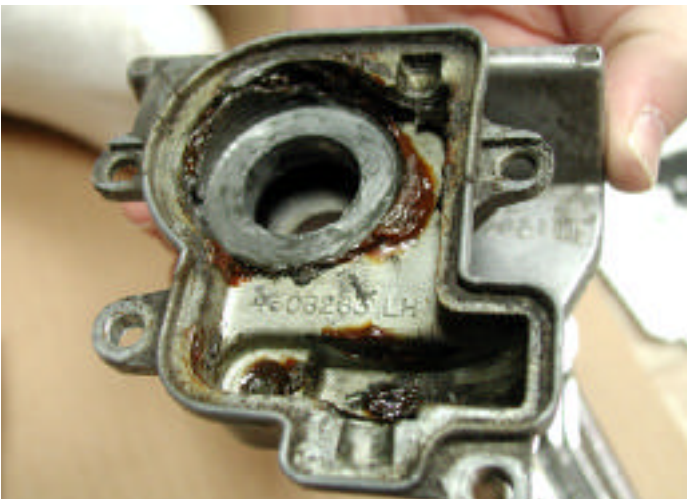
This is the underside of the clam shell. Be sure to clean up all the old grease and goo because it may (IT WILL) contain bits and pieces of metal shavings.

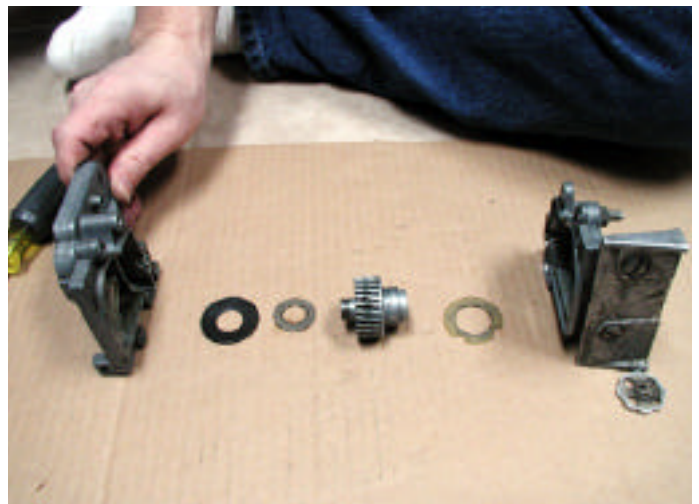
You will find three washers, from left to right, 1 convex black metal washer, one thick silver metal washer, and one nylon washer. There are two gears. One shown here, and who knows what Kip has done with the other one.

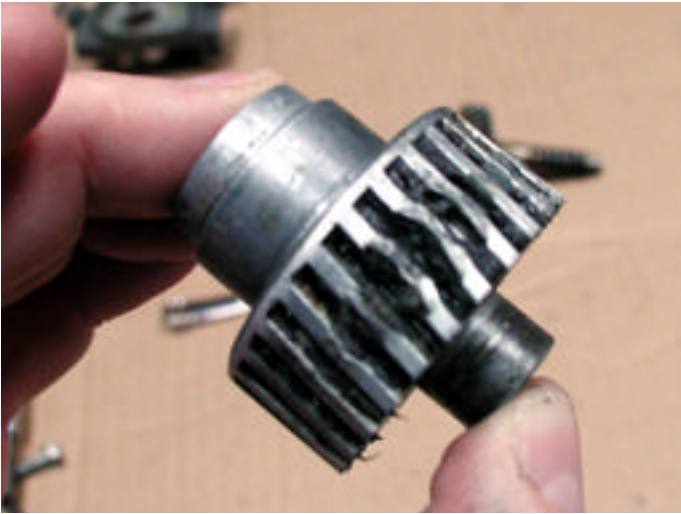
You will find that most likely the teeth on your pot metal gear are now in the final stages of tooth decay and may even have gingivitis.

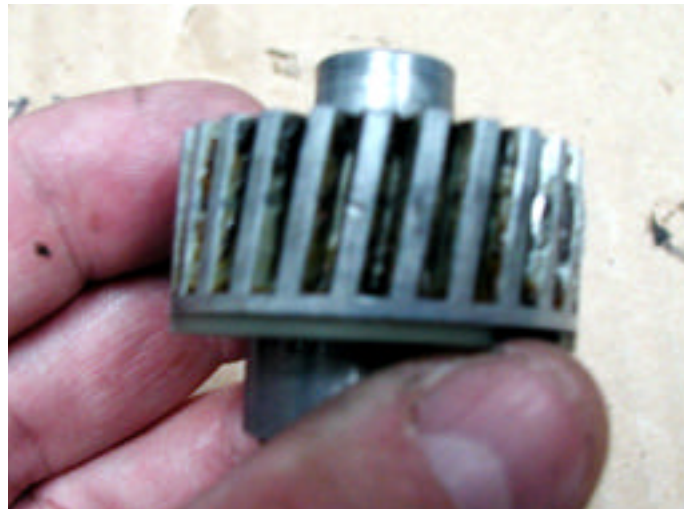
While the opposite side of the same pot metal gear is like brand spanking new. This is because the headlight movement from open to close only utilizes half of the gear's teeth.

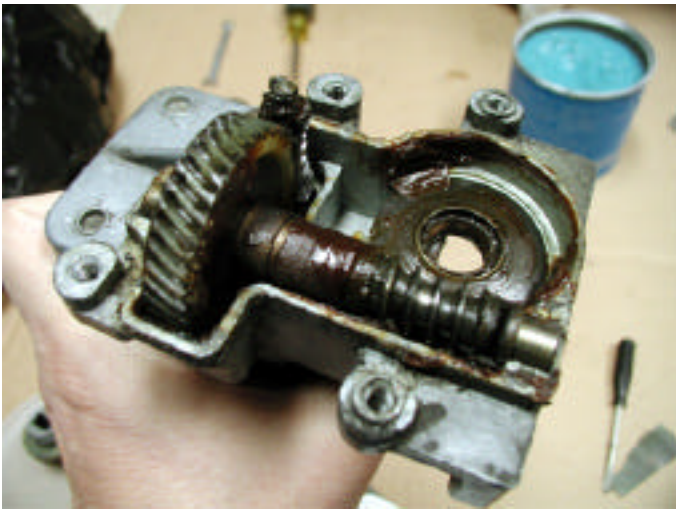
Note that the black curved washer faces curve up toward the removed pot metal gear. Next goes the silver metal washer, then the pot metal gear, then the nylon gear. Be sure to clean the old grease off of everything before reassembly.

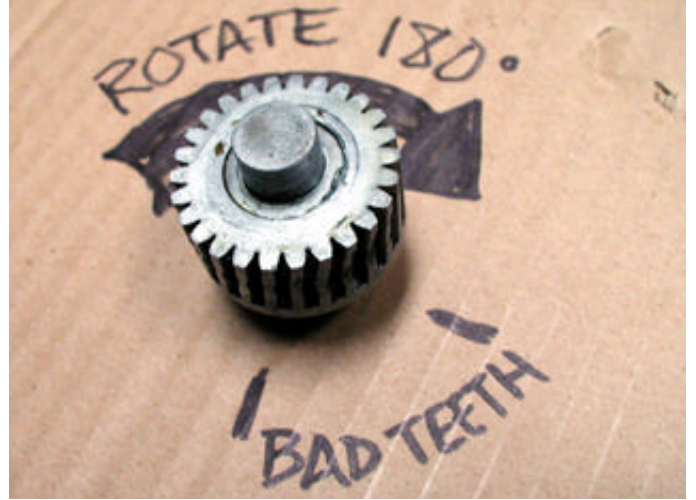
At first I thought I was supposed to "flip" the gear 180° which I soon found was not possible due to its construction. What you have to do, is rotate it in a circular fashion to put the bad teeth away from the worm gear.

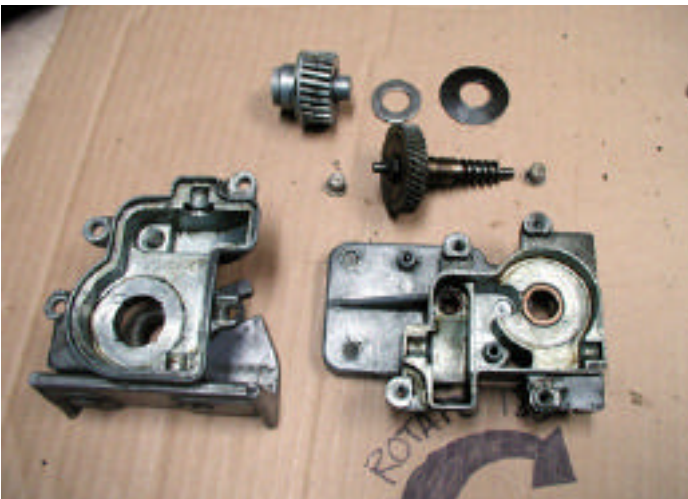
Notice my really clean parts and housing. You will do well to clean your stuff this thoroughly. After all cleanliness is next to godliness you know.
