http://forums.corvetteforum.com/c1-and-c2-corvettes/2210673-carter-wcfb-anti-stall-fix-and-misc.html

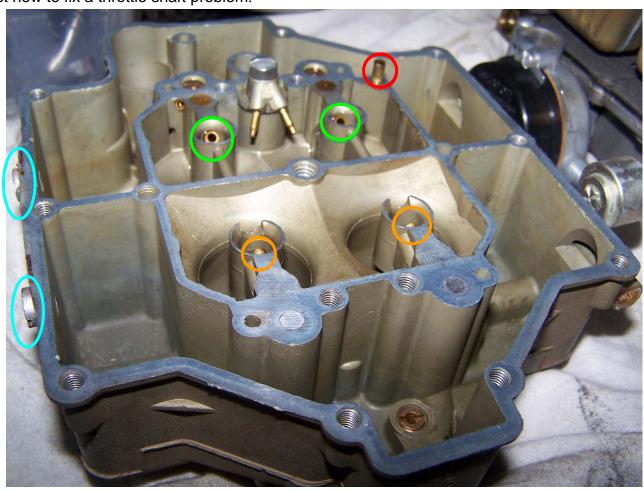
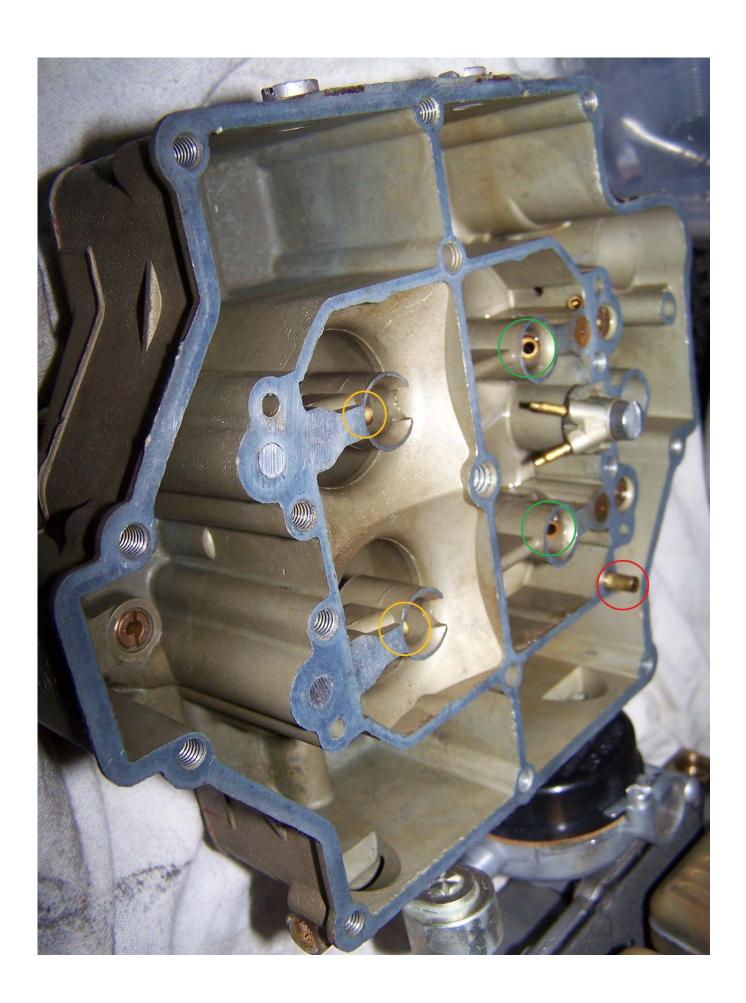
I get asked about this quite a bit so I thought I would show the fix in an actual carb while I have mine torn down. The little bushing (circled in red) keeps gas from sloshing into the choke passage on hard left turns...not all cars need it but many of these old carbs benefit from it. I run it in both of my 2X4 carbs. It's just a short tube that is tapped lightly into the carb body.

While I have the carb apart another item worth noting is the angled cut nozzles in the primary bores (**circled in green**) - this nearly 45 degree angle is distinctive of the 270HP carbs. Other WCFBs, even those with the 6-1299 numbered air horns, are not necessarily the high horsepower carbs. Compare the angled nozzles to the straight-cut nozzles in the secondary bores (**circled in yellow**) - this is typical of the nozzle configurations in **both** primary and secondary low-horsepower carbs. You do not have to have the carb apart to spot these differences - just look down the throat from the top.

Another interesting feature is the two large screws (circled in cyan) on the <u>outside</u> of the body on the left side of the picture that enter the float bowl. Some say that these are like the Holly float level sighting screws and fuel should just come up to the bottom of the screw hole. I've rebuilt 5 of these carbs now and the 2-3 I checked did not have fuel <u>anywhere near</u> the bottom of these screw holes when the floats are set exactly per the ST-12 parameters. They sure look like they should be float level sight holes but they don't seem to work (not for me anyhow).
