Corvette

Overview of some Corvette (mid-year) door anatomy

Dave Zuberer, 2004

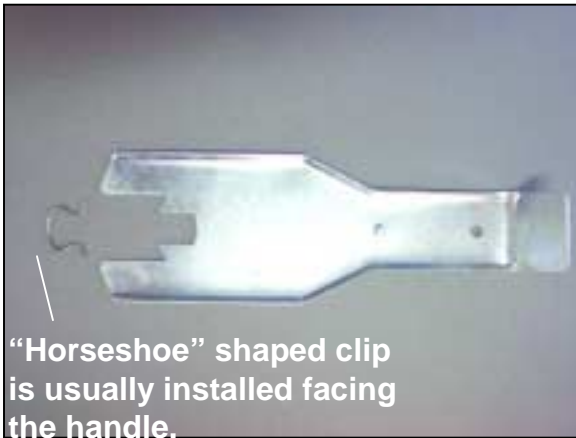
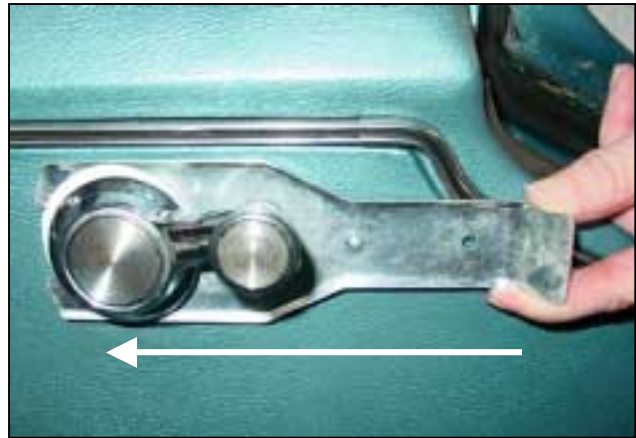
Figure 2: Crank and lock clip removal

Tool for removing window handle/lock retainer clips.

Clip is usually removed in this direction

- Remove window crank handles using the clip removal tool (**Figure 2**; available at most auto-parts stores, Sears, etc.). Clips are usually installed with the open end toward the handle. . If you have standard windows, remove the crank as you would for the vent window crank handle.
- Remove the lock knob using the same tool
- Unscrew the door opener knob from the shaft.
- Remove the two screws from the top and bottom of the door pull
- Remove the two large screws from under the armrest.
- Remove the 5 door-panel clips (**Figure 3**). At this point you should be able to pull out the bottom of the panel and raise it from the top support of the door.

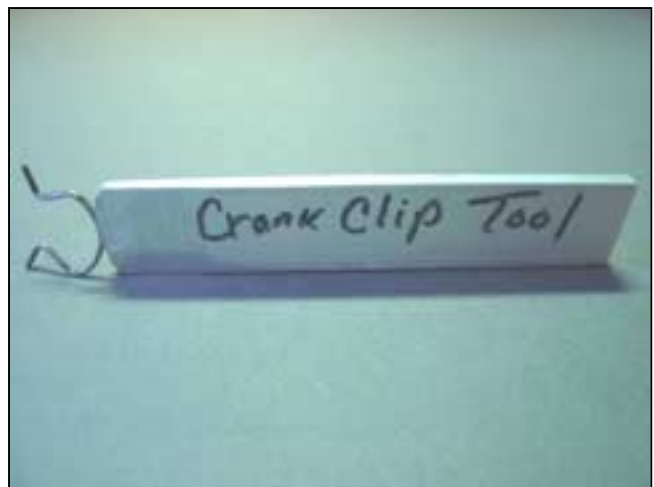
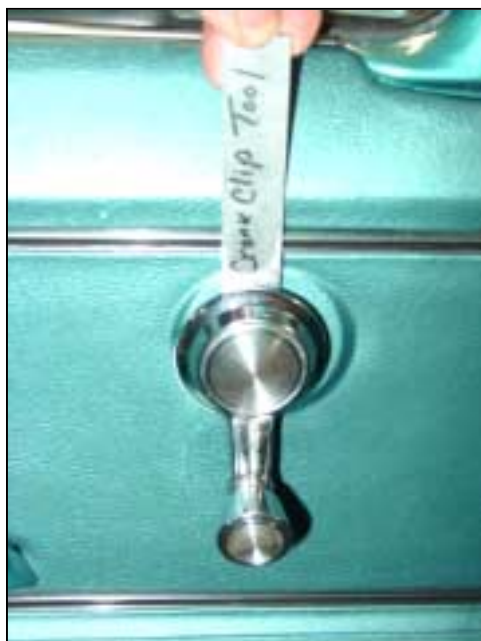
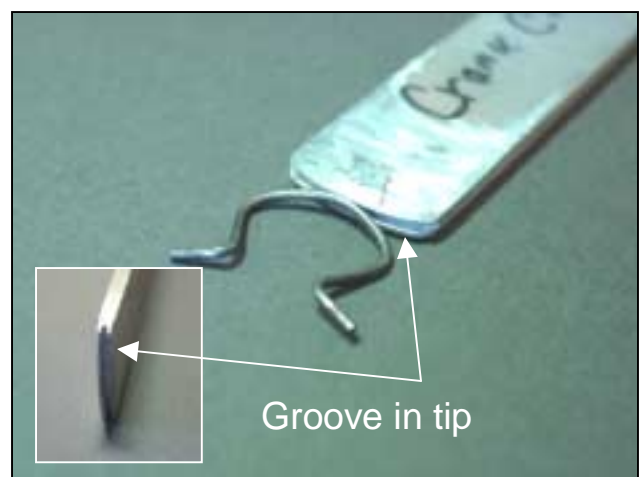
Clip-Install Aid: Here is a tool that I made to assist in installing the horseshoe clips. It's made from 1/8th by 3/4" aluminum bar tapered by sanding both sides. The groove was cut in with a hacksaw. We "pre-staged" the clip onto the window crank and with the tool engaged as seen at lower right, slid the handle onto the shaft and pushed the clip into place.

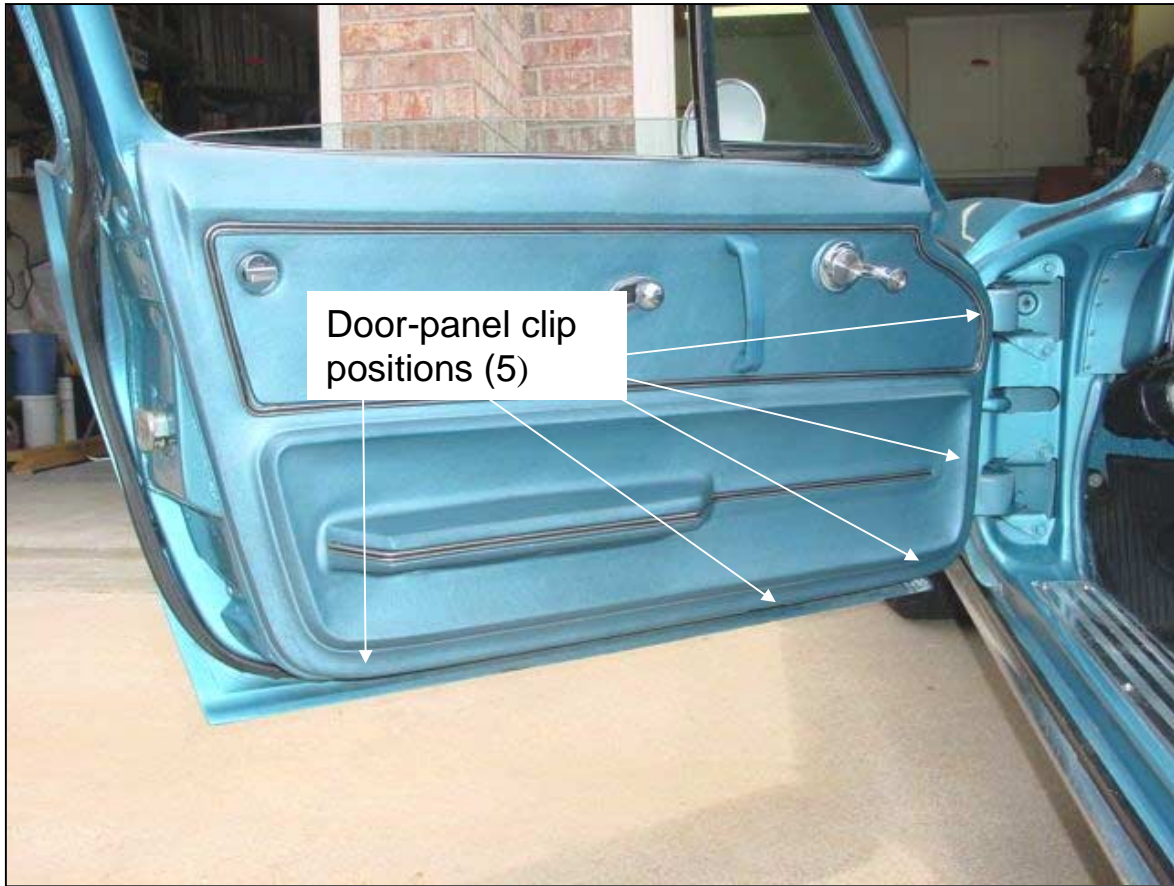
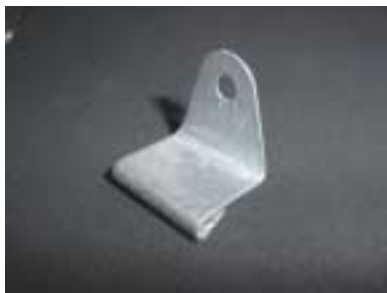
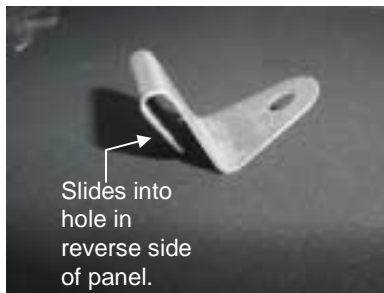
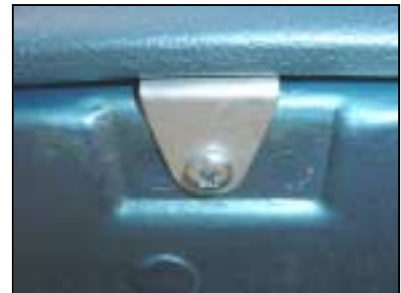
Figure 3: Door-panel clips: removal and installation

Installed panel clip

Door panel clips. These clips slide into the rectangular holes on the back of the door panel. We made some “butterfly” reinforcements out of the metal strapping you can find at any lumber yard. The reinforcement is slid between the foam and the pressed cardboard of the panel and centered by pulling on the small hole with an awl (see next figure). We only had to remove one staple on one panel. This could vary.

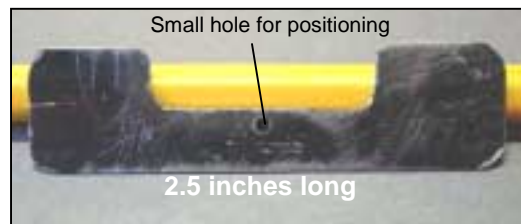
“Butterfly” reinforcement for door-panel clip holes.

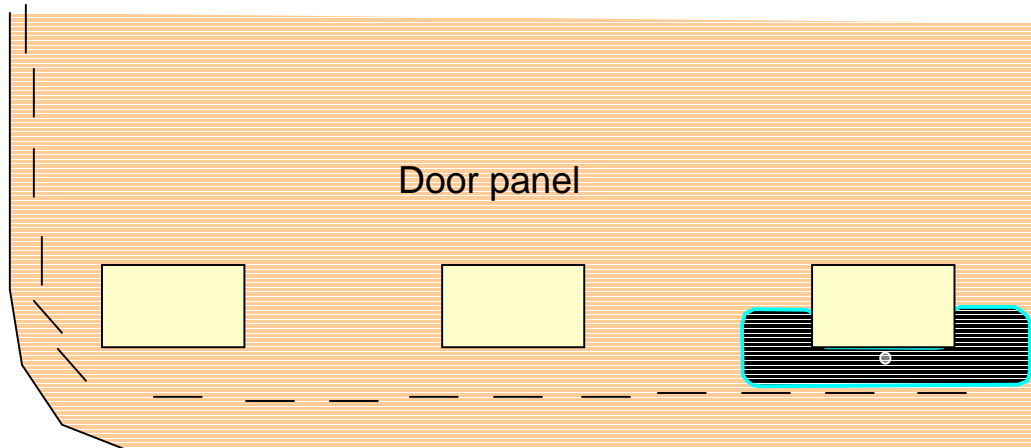
Figure 4: Door-panel clips con't.

Inserting :”butterfly” reinforcements.

Slide metal between foam and board

Push in until metal fits inside of hole.

Push right side down between board and foam and slide to center using the hole and awl.

Slide metal back to center and then down so that it cannot be seen

Holes obviously not to scale!

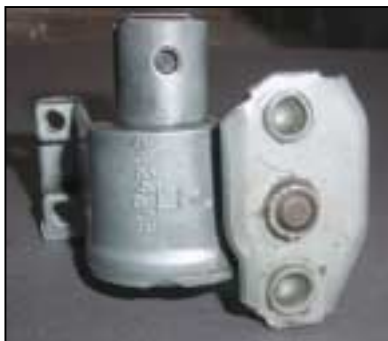
Normal regulator

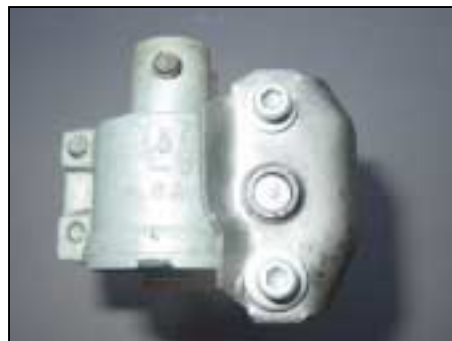
Repaired regulator

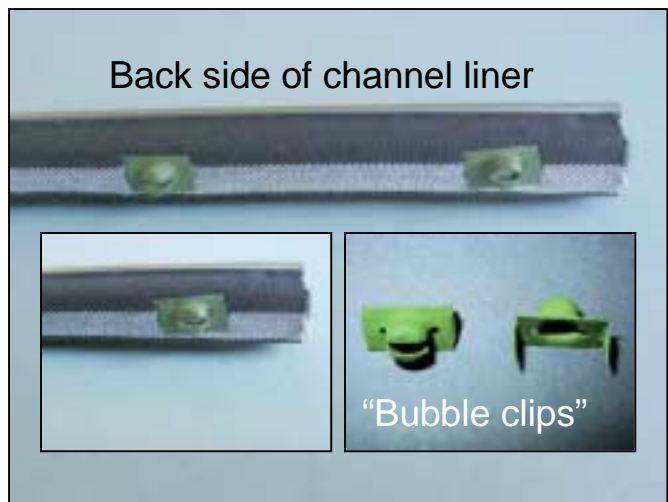
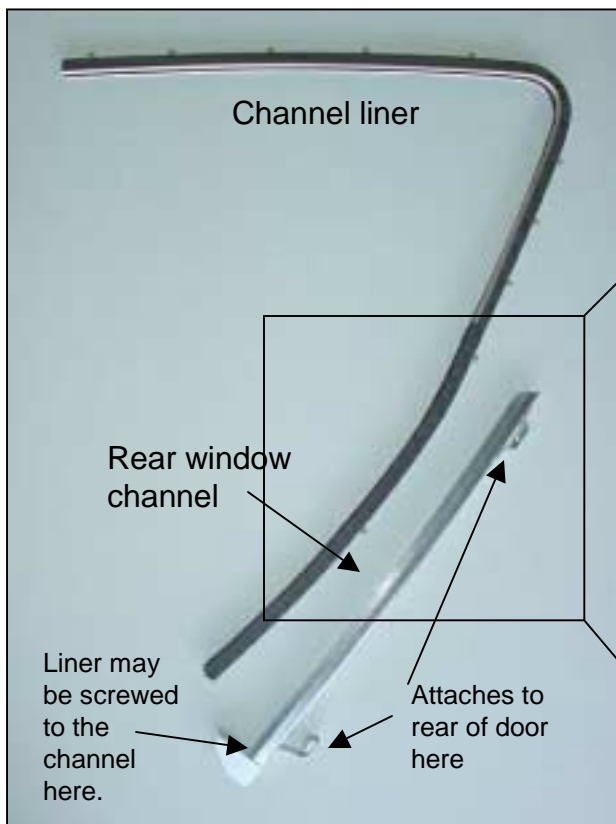
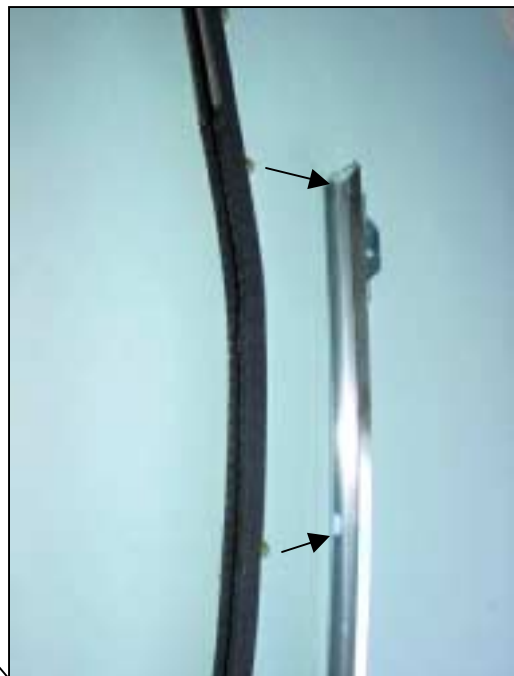
Figure 7: Rear window channel liner removal

Upper window channel liner is removed by pulling down gently with pliers to release the green "bubble" (my term) channel-liner clips. The channel is attached to the lower window channel with two of these clips and a small screw at the bottom. The rear channel may be removed without removing the whole liner by detaching the two clips and the screw. With the channel removed, the side window can be removed without having to take the vent-window assembly out of the car.

With door panel off and access covers removed as above, raise the window partially and add some duct tape “handles” to the front and rear top of the window glass (Figure 9). Then raise the window to the full up most position. Locate the small screw in the bottom of the window channel liner (see Figure 7) and remove it. Pop the channel liner from the channel by loosening the two “bubble” clips holding it to the lower rear window channel. It may be necessary to remove the two channel mounting screws from the rear of the door (Figure 8).

The installation is essentially the reverse of the steps above. After you have made any repairs / restorations of the vent window assembly, window channel liner, etc., place the vent assembly back in the door pocket and guide the lower stud back through the hole in the bottom of the door (Fig. 1B). (You can remove the stud during this operation if need be. You can reach in through the access panel to reattach the stud). You can leave the vent assembly loose at this point so long as it fits snug against the front of the upper frame. The window channel liner (one-piece upper and lower rear) should have been replaced earlier. Leave upper front bubble clips detached so you can get the vent assembly into place (see Figure 7). It will be helpful to slightly squeeze the two bubble clips that go into the rear lower window channel (still unattached at this point). It makes them easier to insert into or and remove from the channel if need be (Fig. 7 lower right).

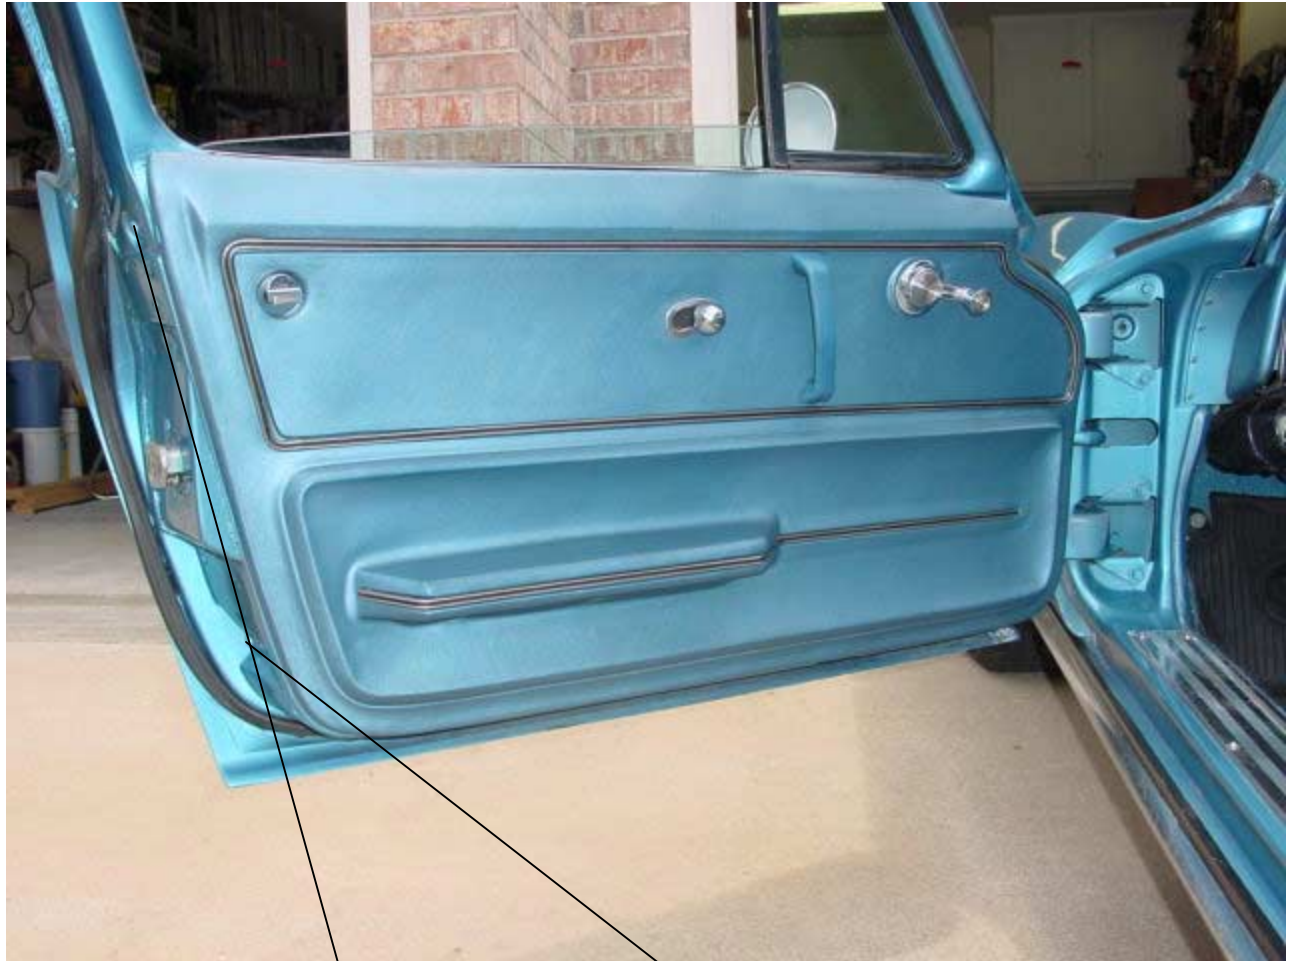
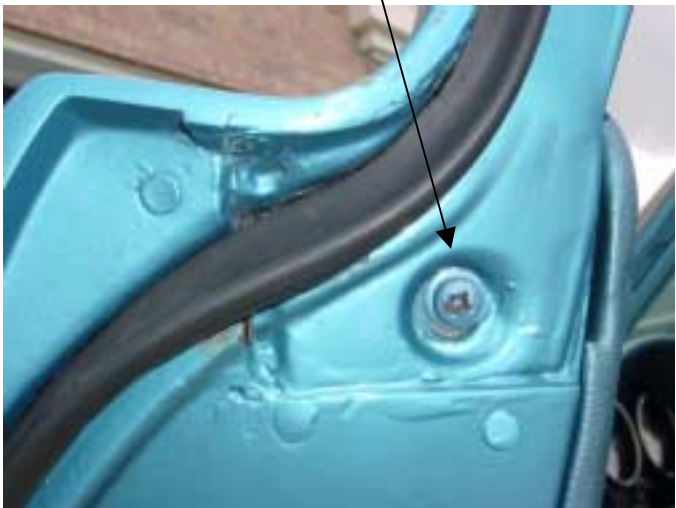
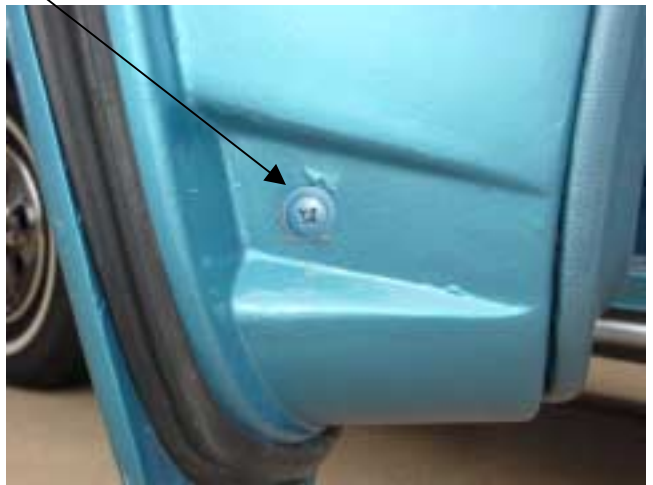
Figure 8: Rear channel mounting screws. These retain the rear window channel (see Fig. 7) to the back of the door.

Engage the front edge of the window into the front channel (back of the vent assembly) and raise it up into the upper rear channel using the tape handles. Have a helper hold it up (or tape it) while you slide the lower channel (removed earlier) up behind the dangling channel liner and into position. The upper bubble clip (of the two lower ones) can be difficult to engage here. That is why squeezing it earlier might be helpful. Once the two lower clips are engaged in the lower channel, replace the small screw at the very bottom of the channel liner (can probably be left out without hurting anything). Reattach the channel using the two screws removed from the rear of the door earlier (Fig. 8).

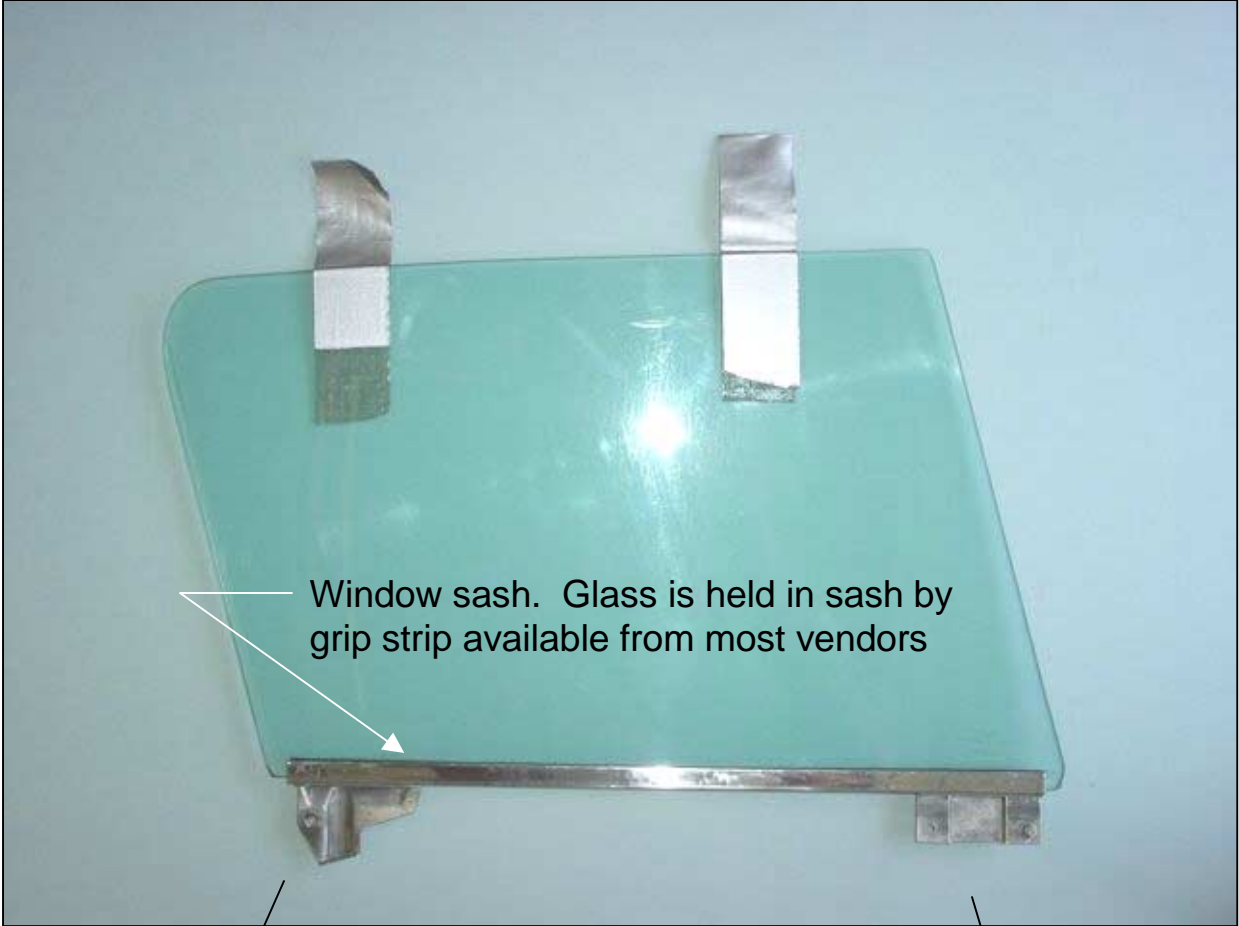
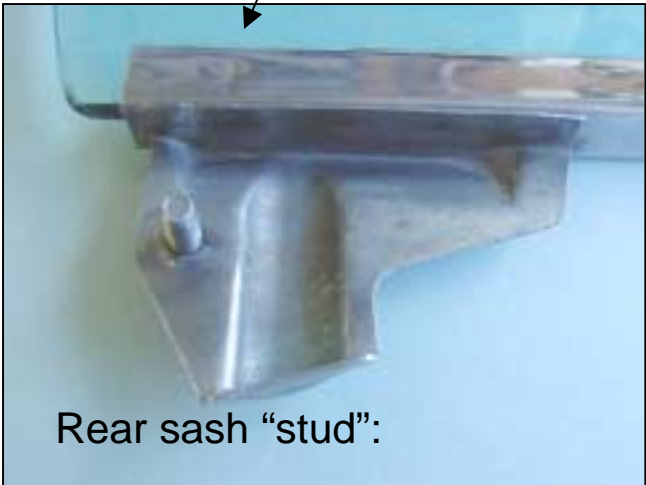
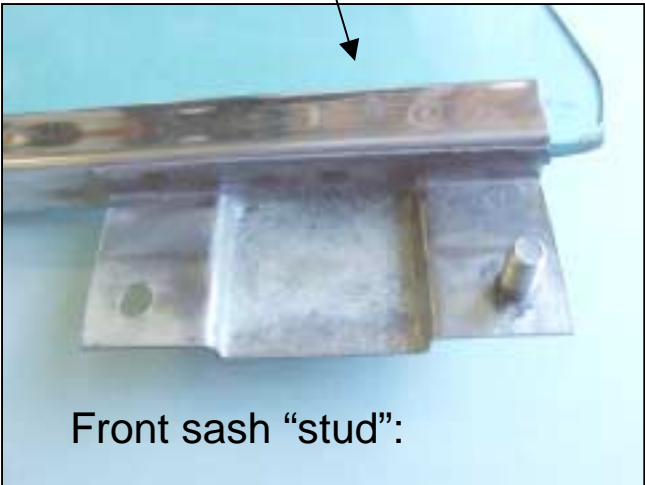
Figure 9: Window sash and mounting studs.

These studs mount to the upper roller track with hex nuts with captured star washers. The nuts are accessible when the window is positioned so that you can see them through the holes in the fiberglass door panel (Figure 1B)

Once the channel is removed, carefully raise the window to where you can access the nuts on the studs on the window sash (Figure 9 and see figure 1B). Remove the nuts and push the studs out of the holes in the sash. Hold the tape handles (better yet, have a helper hold them) while you carefully lower the window lever mechanism to its lowest position. Now lower the window into the door pocket and rotate it slightly so the rear comes up a bit. You should be able to turn the window enough to bring it up through the gap in the top of the door.

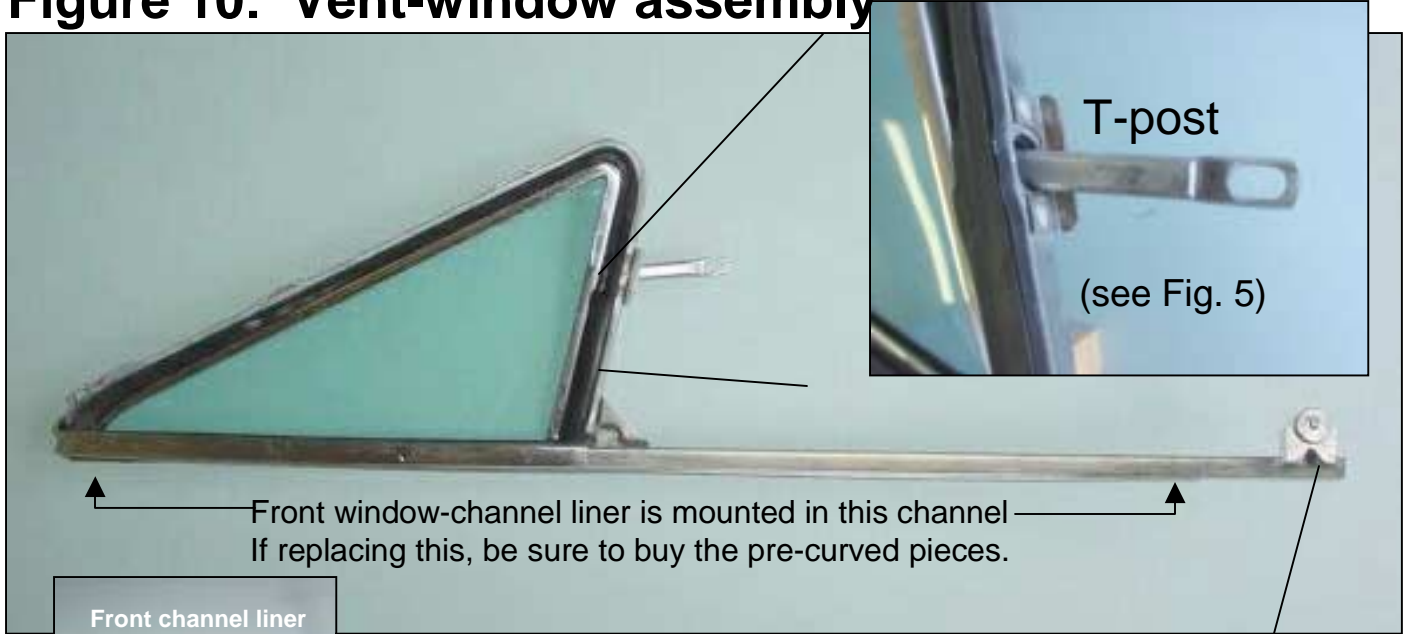
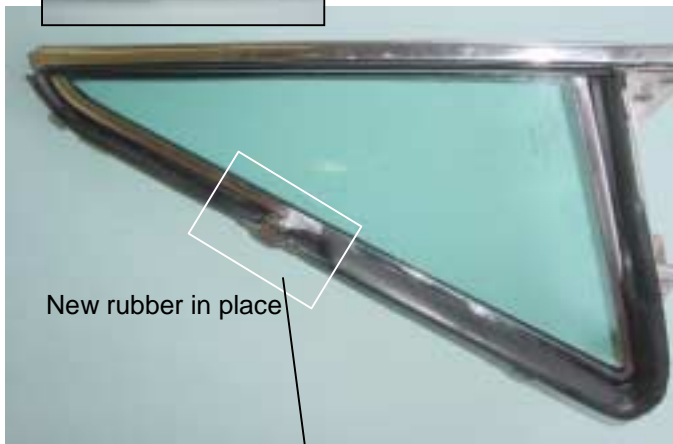
Figure 10: Vent-window assembly

This is a vent window pivot hinge that has been replaced earlier. Note poor welding.

With the side window out, removal of the vent-window assembly (Fig. 10) is much easier. Remove the nut from the stud at the bottom front of the door (Figure 1B and Figure 10) and carefully push the stud back into the door pocket. Remove the screw holding the assembly at the top of the door (just below the vent window (Figure 1B).

If everything works, you can replace the screws (4) in the vent window frame (Fig.11). Replace the large screw securing the vent window channel to the door (Fig. 1B). Replace nut on lower stud and adjust in or out as necessary (Fig. 1B and Fig. 10)

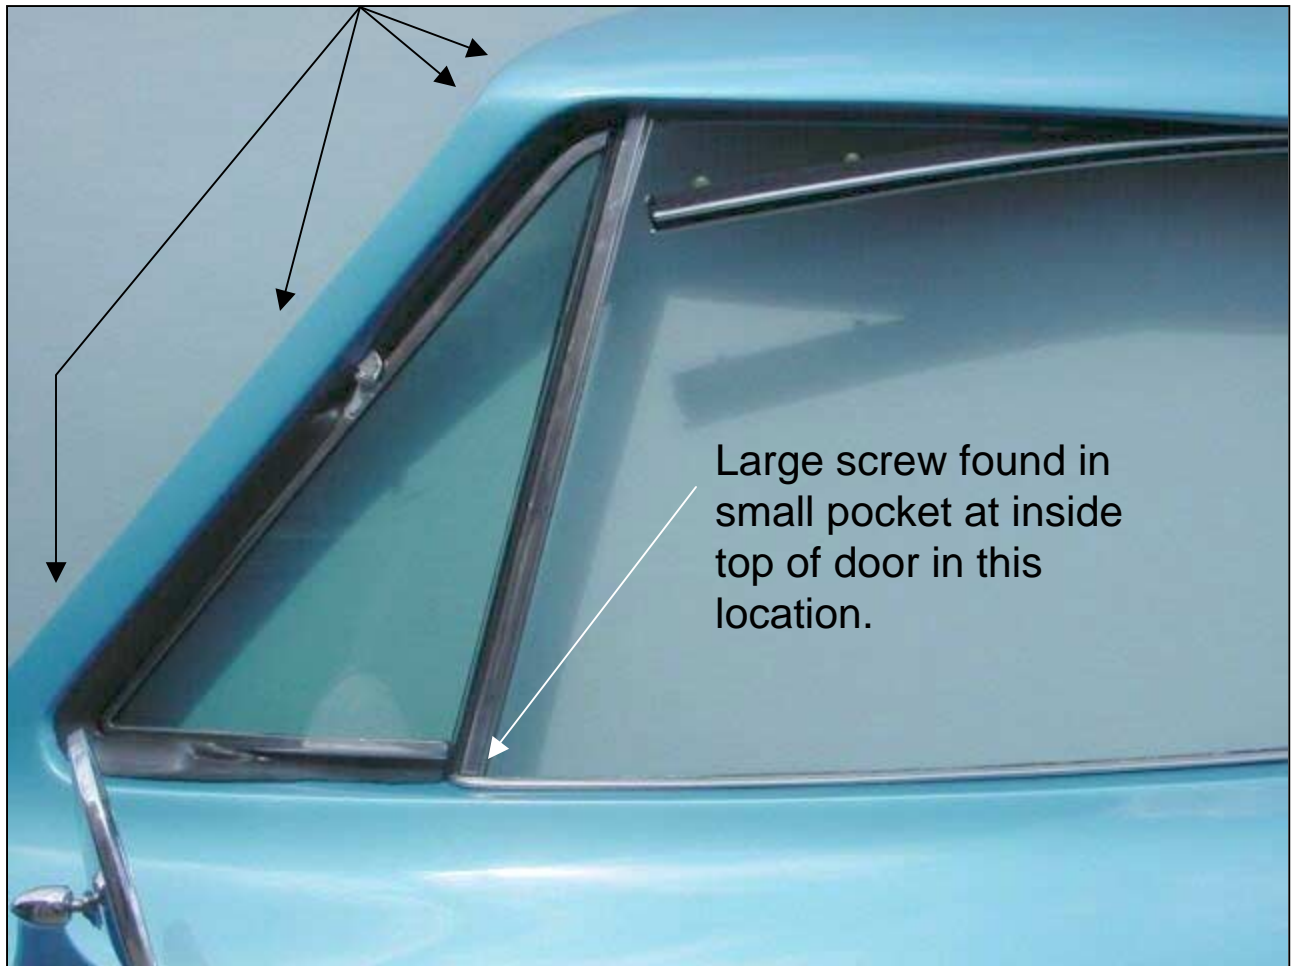
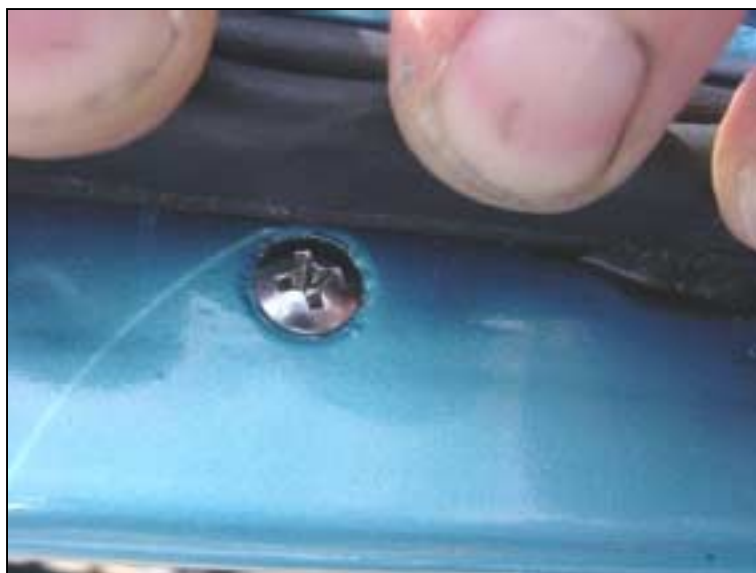
Figure 11: Vent window screw locations

Vent-window mounting screws (4)

Peel back door weather strip to reveal the 4 small screws retaining the vent-window assembly to the door frame.

Peel back the weather stripping along the leading edge of the door to reveal four small Phillips-head screws (two near the top curve, one in the middle and one near the bottom (Figure 11)). Remove these screws. With these screws removed, the lower stud pushed inside the door and the larger screw removed from near the top of the door, the assembly should move backward fairly easily and you can raise it out of the door taking care not to hang up the bottom stud as you bring it out. You need to have the window channel liner disengaged from the upper front of the doorframe (see Figure 7) so you can bring the vent assembly back. At this point, you may already have it out of the doorframe.
