This is a task I was dreading. The headlight motor rebuild. I could send them off for \$128 per motor, or do it myself. I decided to do it myself after Gary C from Castle Rock...

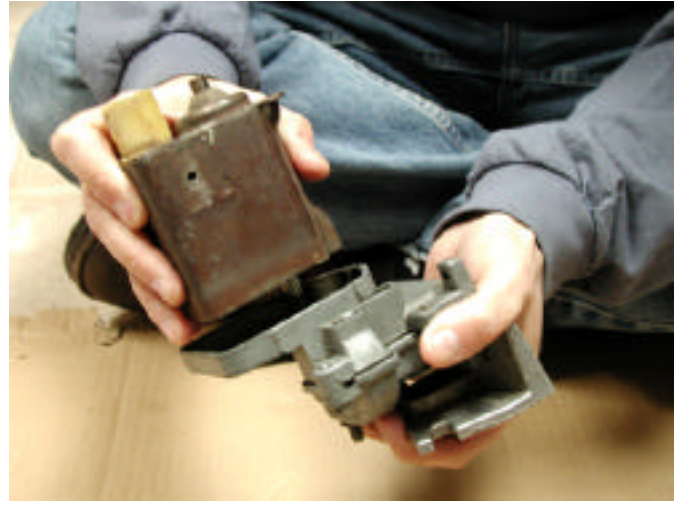
Pull the two sections apart. You may want to do this the opposite of how I show it here in case your "junk" wants to fall out. In my case it didn't, but it could have I suppose.

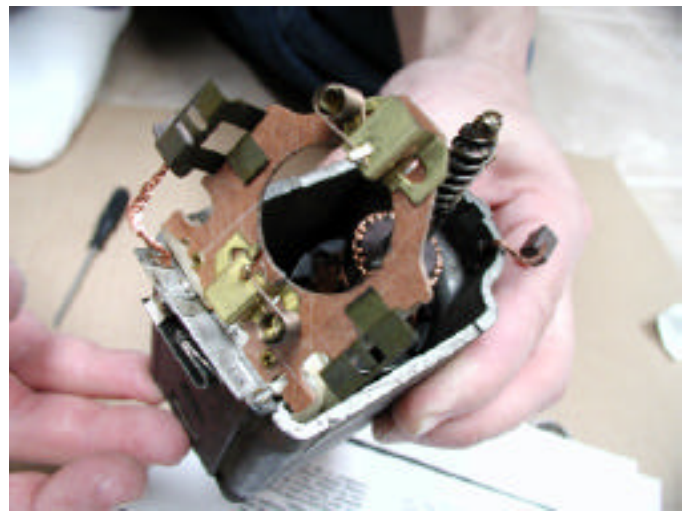
Do not fear the jack in the box brushes, they will spring out of their casing, but will stay attached via copper wire.

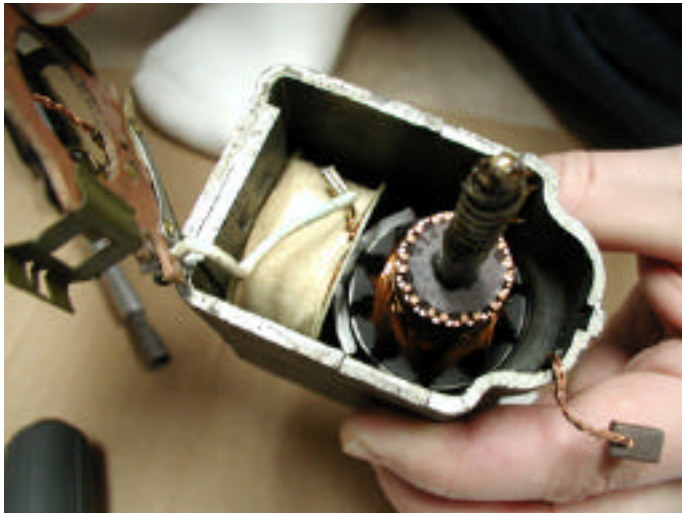
Once the brush assembly is out of the way you can remove the motor for inspection. If it is hesitant to come out DO NOT FORCE IT. Sand the end of the spindle that protrudes from the bottom of the casing (see arrow in next pic)

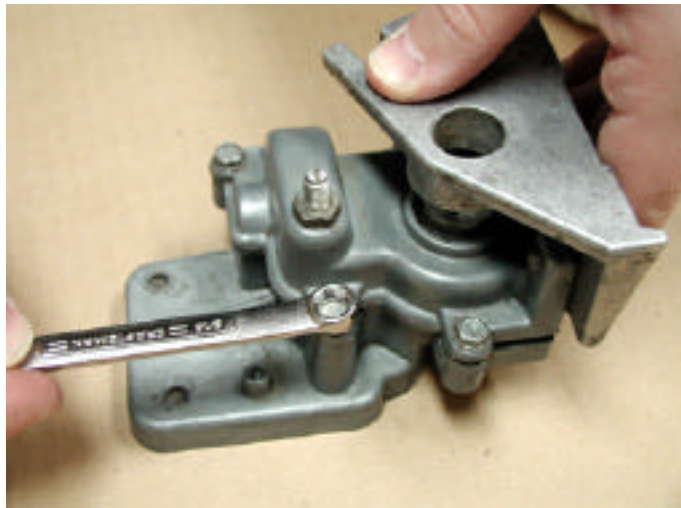
Next remove the four bolts that hold the gear section together. Most of the problems you are going to have are in here. But fear not... it is so easy it makes you want to file charges against those guyz charging \$128 per motor to rebuild them.

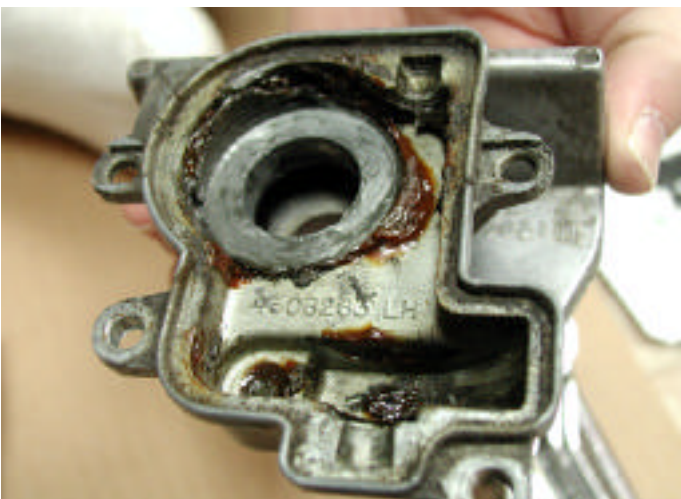
This is the underside of the clam shell. Be sure to clean up all the old grease and goo because it may (IT WILL) contain bits and pieces of metal shavings.

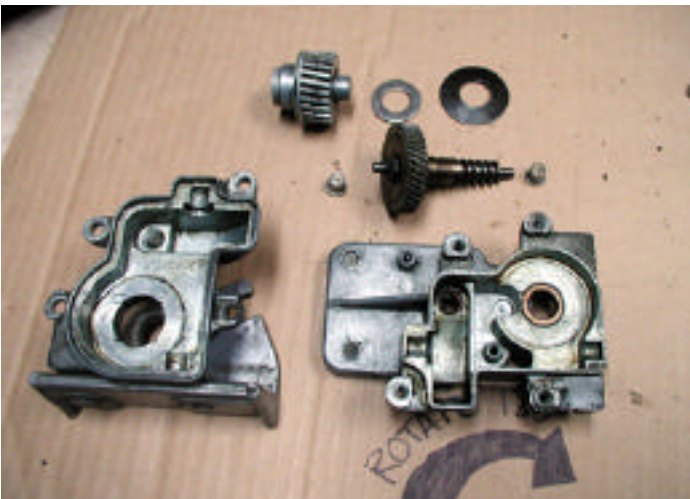
Notice my really clean parts and housing. You will do well to clean your stuff this thoroughly. After all cleanliness is next to godliness you know.
