**STEERING WHEEL & STEERING SYSTEM CENTERING PROCEDURE
(CORVETTE 1963-82, CAMARO/FIREBIRD 1967-69, AND NOVA, SKYLARK,
VENTURA, APOLLO 1968-74, & OTHER GM REAR STEER VEHICLES)**

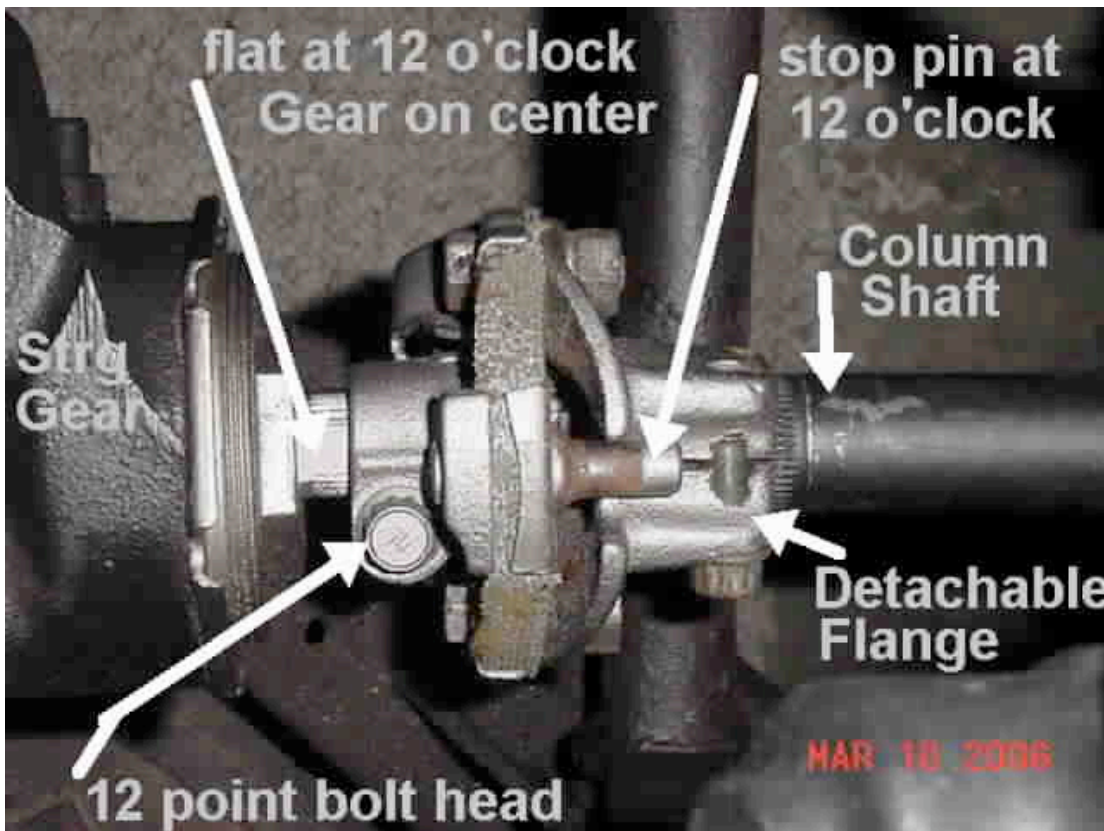
Picture of a C3 Corvette looking over the front fender, straight down at the steering gear, flexible coupling, and steering column flange. Components are shown with the steering gear exactly on center. Many GM steering columns have a press fit, stamped, lower flange instead of the cast detachable flange as shown.

(VIS-IDEN) With the gear exactly on center, the flat on the input shaft should be at 12 o'clock and the twelve point head on the bolt that attaches the flexible coupling to the gear should be sticking straight up. The stop pins on the flexible coupling should be vertical (one at 6 o'clock and the other at 12 o'clock) as shown in the picture on page 2.

(VIS-IDEN) Up until early 1969 the steering gear input shaft and the flexible coupling had what is called "full serrations." There was no flat on the gear input shaft nor was there a flat machined into the flexible coupling flange that attaches to it. This means that the flexible coupling will assemble on any of the 30 spines (or serrations) on the gear input shaft. However, you still want the gear to be on center and the flexible coupling stop pins and the pinch bolt to be oriented as shown in the picture on the preceding page.

Early in the 1969 model year, steering gear input shafts and flexible coupling flanges were changed so that they had mating flats. The flat on the gear input shaft will be at 12 o'clock when the gear is exactly on center. You can see a portion of the input shaft flat sticking out from the flexible coupling flange in the photo on the previous page.

(VIS IDEN) On T&T or tilt columns, with the chisel mark at 12 o'clock the lower end of the column must have its clamp bolt horizontal and passing through the 12 o'clock position on the column shaft (As shown in the photograph on page 2.) Note that there is a notch on the steering column lower shaft that allows the clamp bolt to pass through. So the chisel mark on the upper steering column shaft and the notch on the lower steering column shaft must both be at 12 o'clock when the steering column is on center.

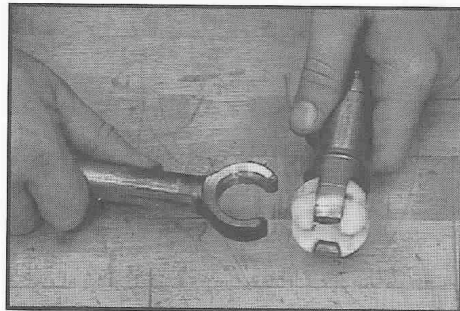
Separating Upper and Lower Shaft Sections

Remove the steering column from the car and disassemble the steering column head so that the upper steering shaft can be reoriented to the lower column shaft at the plastic tilt sphere. It will be very helpful to download the appropriate adjustable steering column disassembly and repair papers from the host website for instructions.

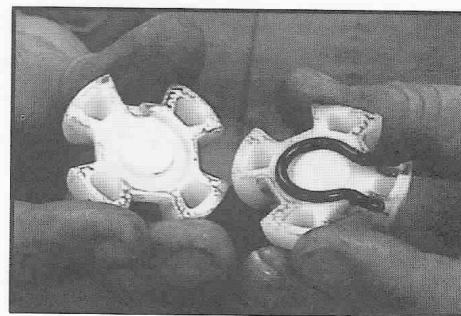
Joint Preload Spring in Centering Sphere
