#09-06-04-026N: Identifying Non-GM (Aftermarket) Engine Calibrations for Gasoline Engines Using Tech 2 or GDS 2 (U.S. and Canada) - (Feb 15, 2018)

Subject: Identifying Non-GM (Aftermarket) Engine Calibrations for Gasoline Engines Using Tech 2® or GDS 2 (U.S. and Canada)

Models: 2005-2006 Chevrolet Corvette – Equipped with any V8 Gasoline Engine

2007-2018 GM Passenger Cars and Light Duty Trucks – Equipped with any V8 Gasoline Engine

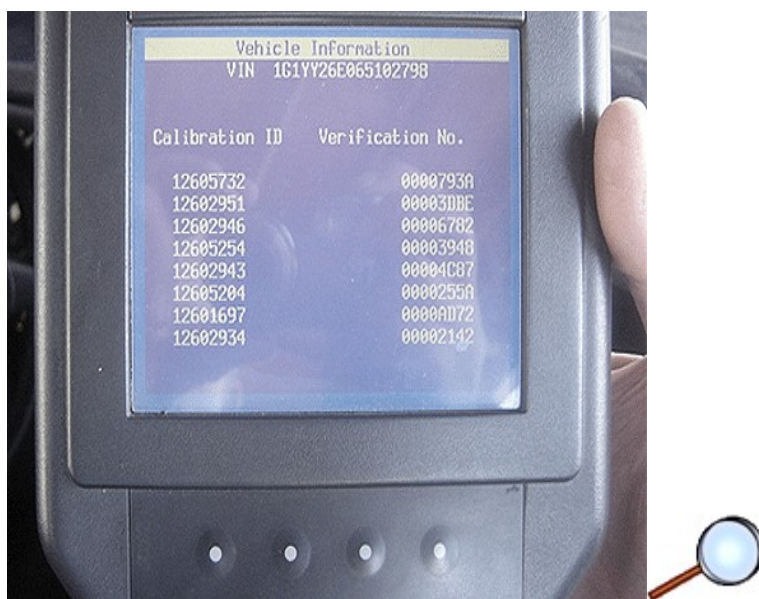
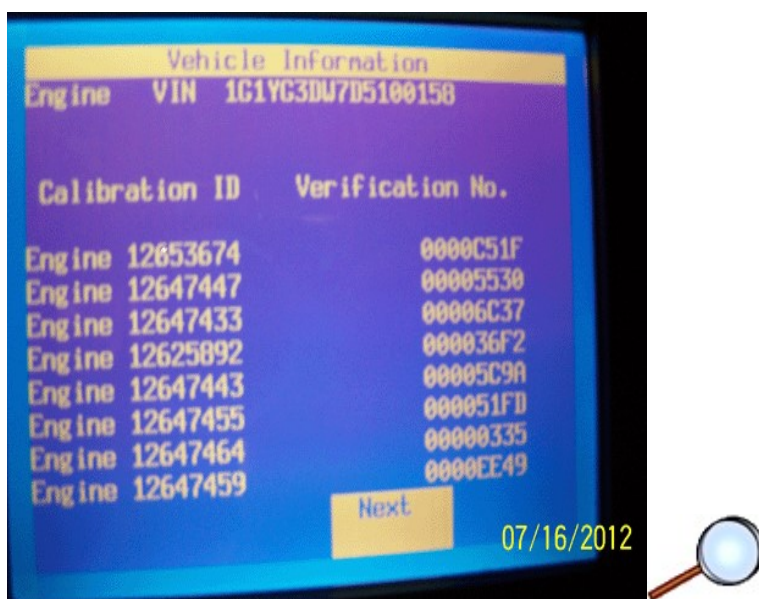
- Two examples of the Tech 2® Vehicle Information - (Engine) Calibration ID and Verification No. screens are shown.
- The Tech 2® Vehicle Information - Calibration ID and Verification No. screen will differ slightly depending on vehicle and model year.

8. Take a **CLEAR** digital picture(s) of the Tech 2® Vehicle Information screen showing the **entire VIN, (Engine) Calibration ID and Verification No. (Number/CVN)** and save it in **.jpg** format.

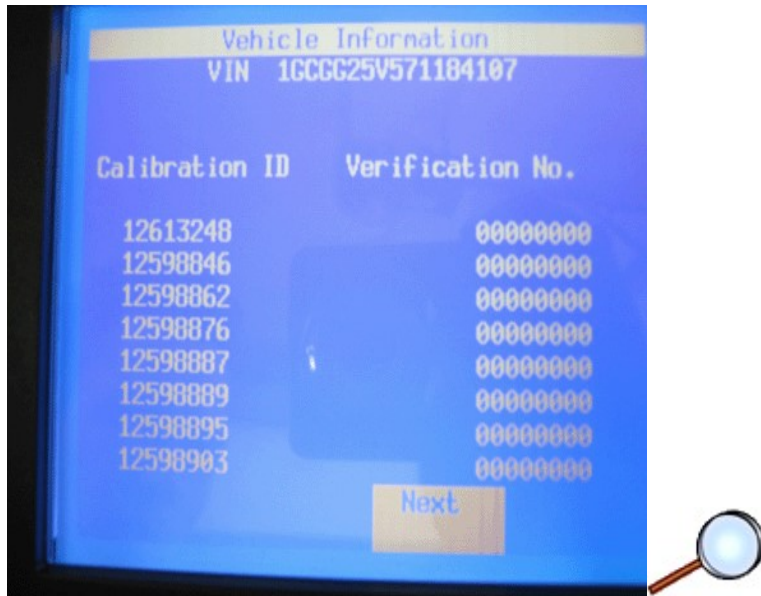
5. Tech 2® Displaying All Zeroes for the Verification Numbers on the Vehicle Information - Calibration ID and Verification No. (Number/CVN) Screen

If the Tech 2® that is being used displays all zeroes for the Verification Numbers as shown, then perform the following steps:

1. Update the Tech 2® with the latest software from TIS2WEB.
2. Turn **OFF** the ignition for 90 seconds.
3. Connect the Tech 2® to the vehicle.
4. Turn **ON** the ignition, and build the vehicle. Observe the Tech 2® Vehicle Information - Calibration ID and Verification No. (Number/CVN) screen for proper operation.
 - ⇒ If the Tech 2® screen still does not display properly, then turn **OFF** the ignition for 90 seconds again. Turn **ON** the ignition and observe the same screen for proper operation.

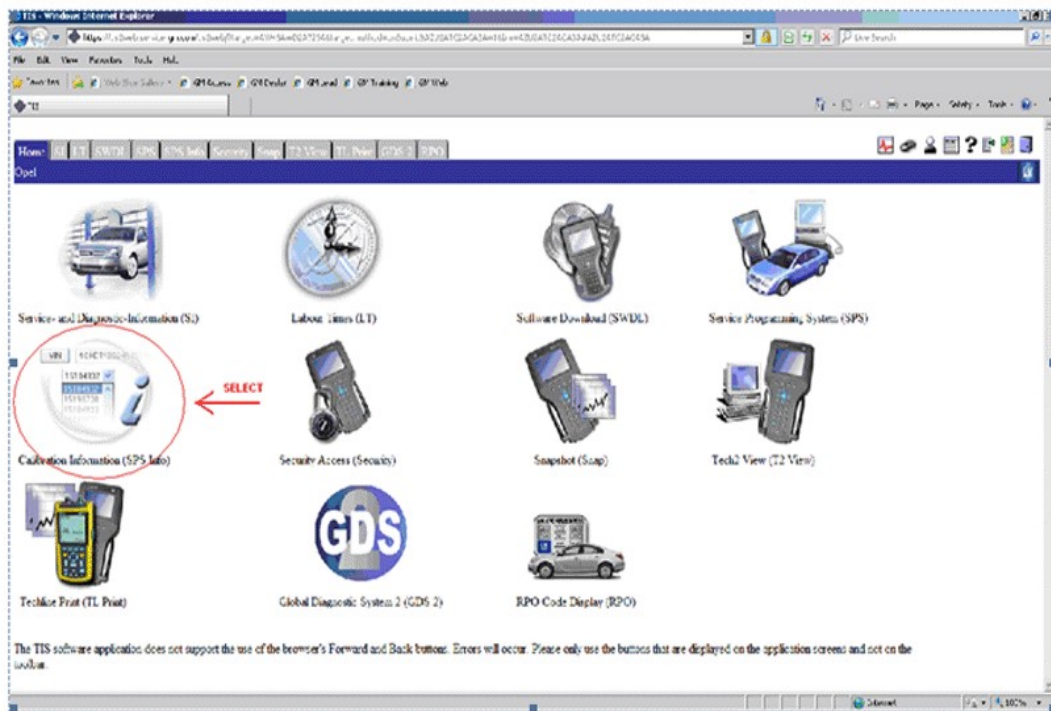
1. Go to: **TIS2WEB Home Page**.
