283 CI Engine Build for Harmonic Balancer, Water Pump, Generator Pulleys & Brackets

I built a parts buck to show a stock 1959 - 1961 to help clear up confusion about brackets and pulleys. I will also show methods to help align the generator to the pulley system, as this design was not ideal and allows much movement during assembly, and some critical areas that must be observed. There are many photos and measurements shown to help visualize assembly.

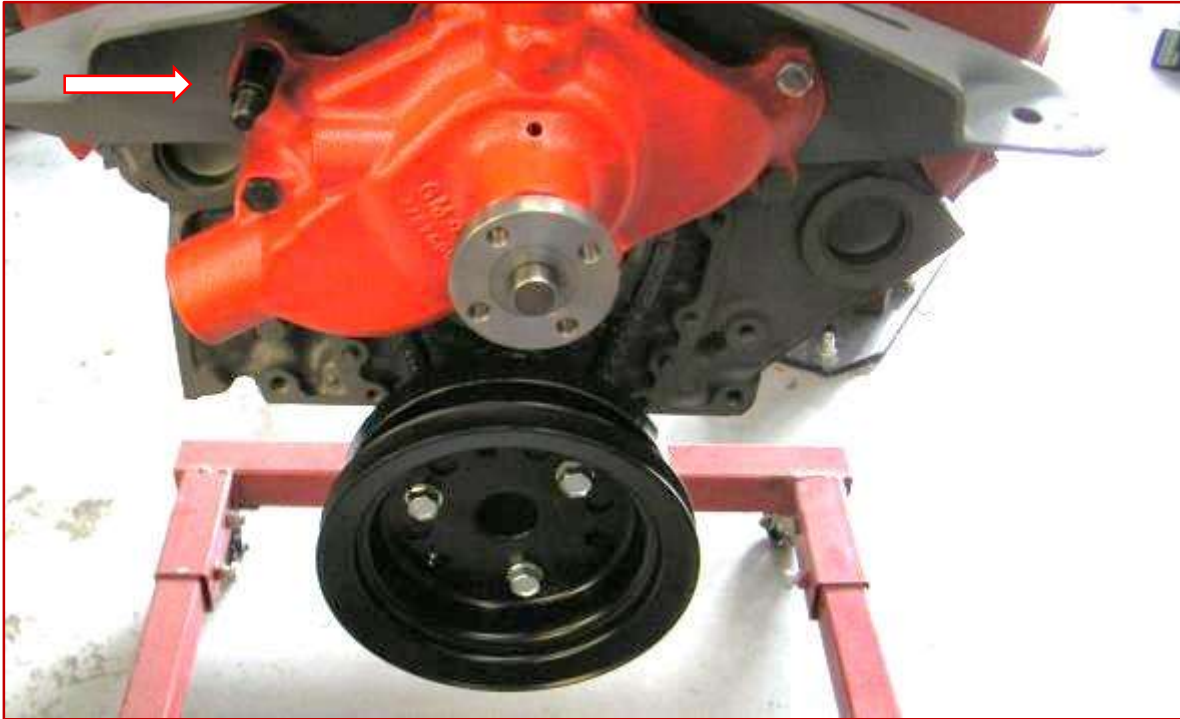
Here is the WP reinforcement mounted on the WP hub before the WP pulley is installed. This item should always be used as pulley condition and life will be extended.

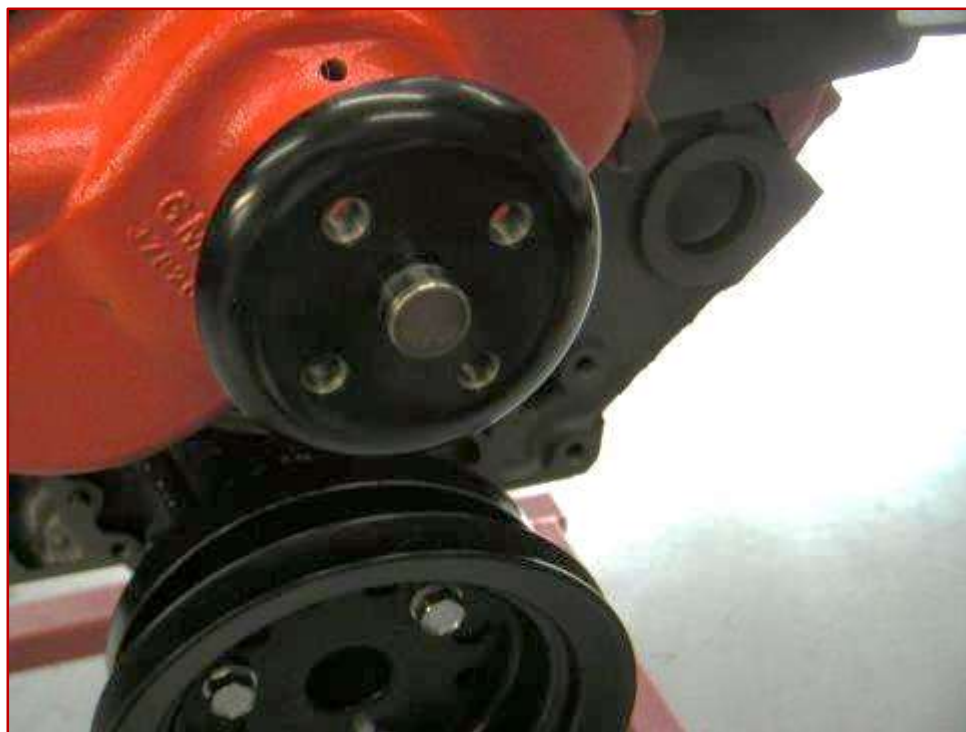
As you can see below, there is a mismatch of the HB pulley to the WP pulley. It's off by about 1/8". Why is this? Variations in pulleys, water pumps and their hubs, and varying gasket thickness can play a role in these tolerances. But there are ways to correct these anomalies.

Here I have added one additional WP pulley reinforcement to help get better pulley alignment. This may not have been done at original build, as it's costly for many cars, but in your case it may make your build easier and produce a better finished product.

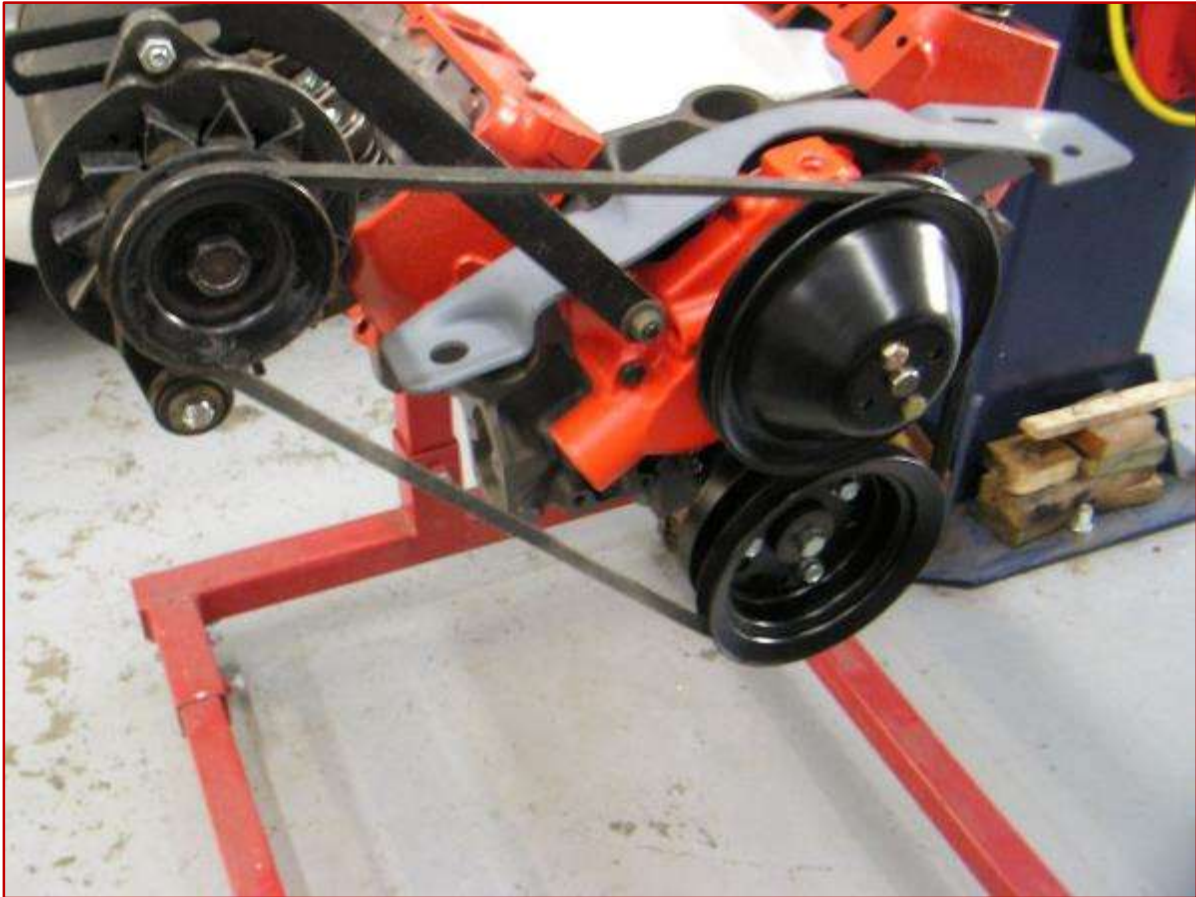
This is where you must make unconventional "adjustments" to the brackets and generator to achieve optimum alignment.

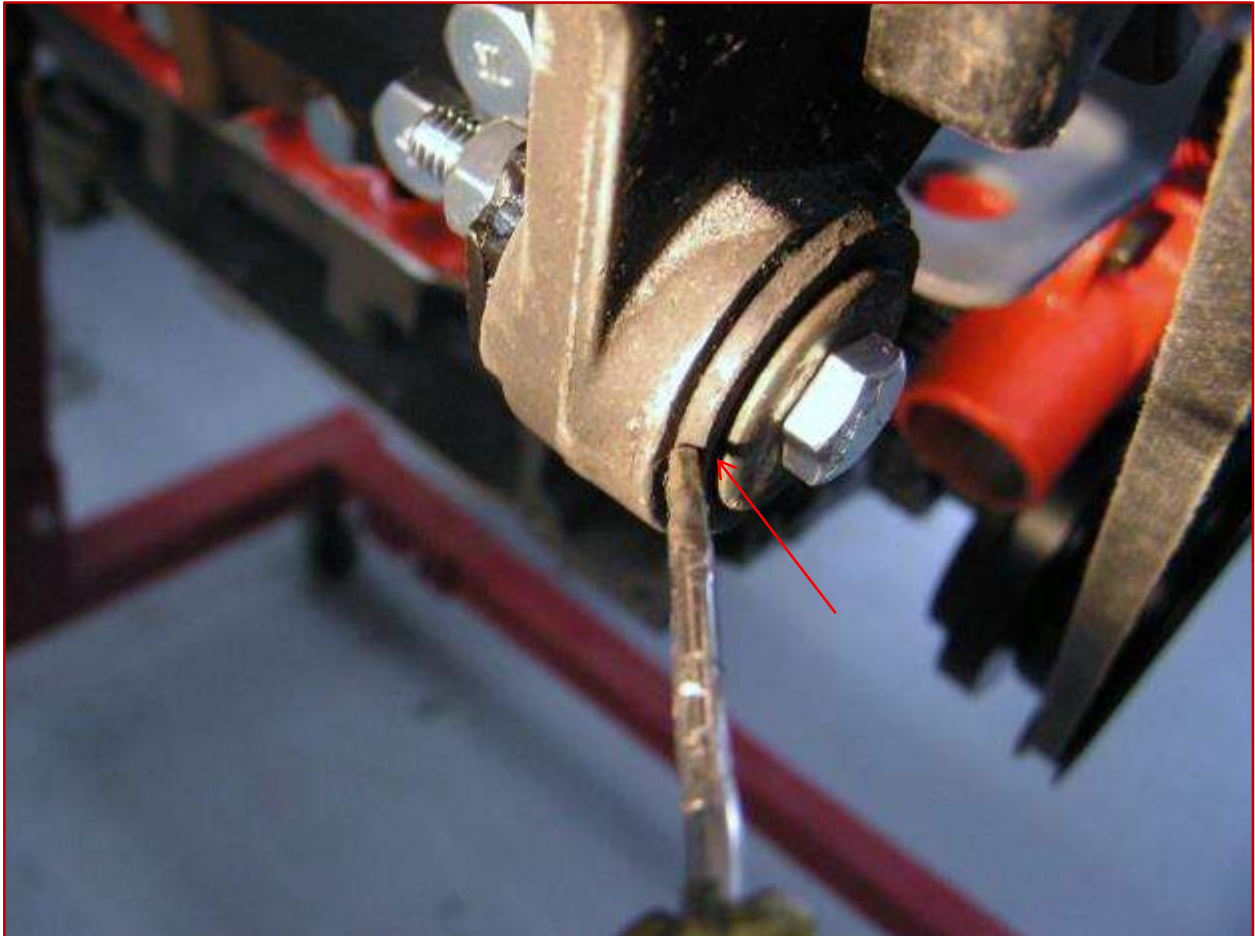
Note the rubber bushings on the lower mounts. One side has a flat outer ring. Insertion direction of these bushings in the generator end-frames can help offset small variances in the alignment. The pointer shows a ridge on one side of each bushing. Replacement bushings do not always have this feature. Because of this, the generator can move forward or rearward when tightening the adjustment brace while pulling the drive belt tight.

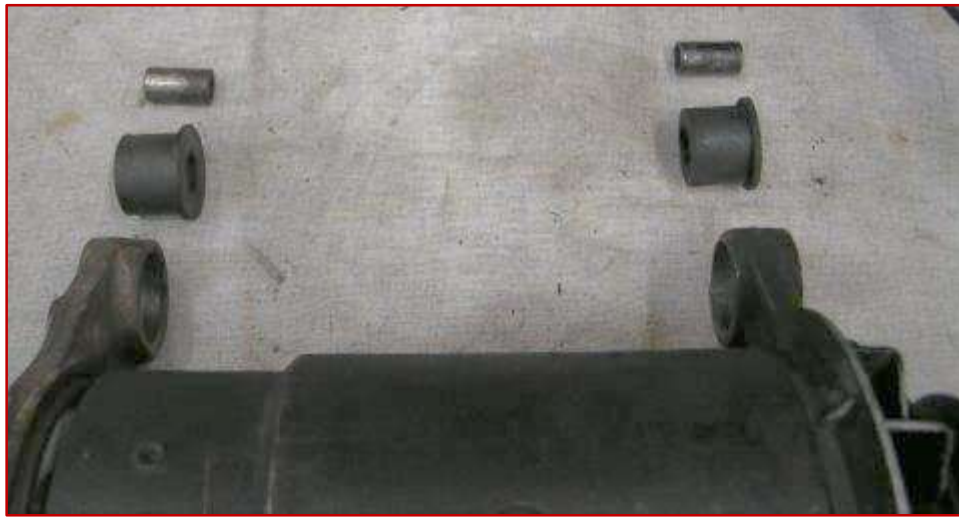
Here are the generator bushings to show their profiles.

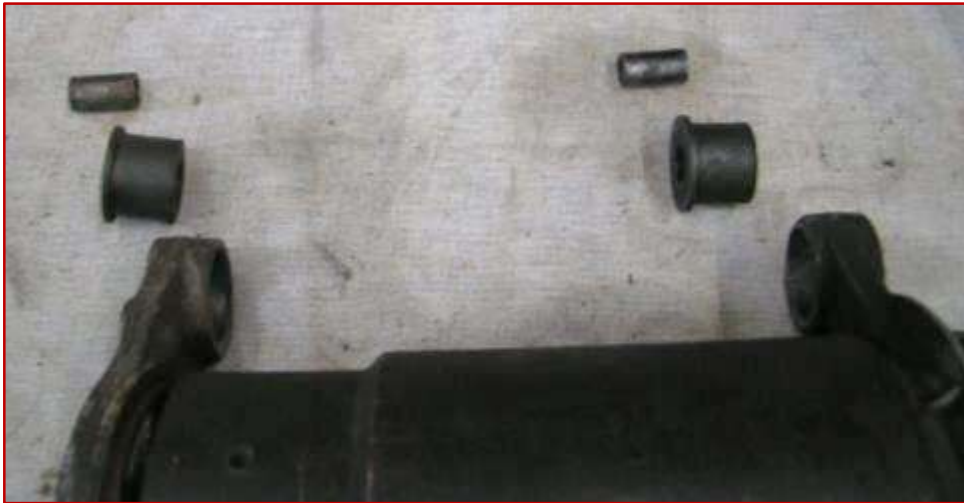
I've reversed them in the end frames.

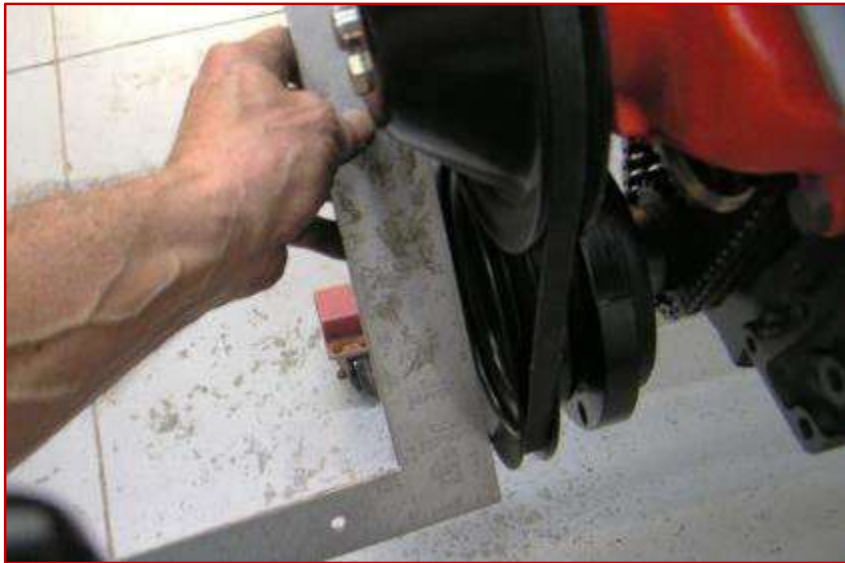
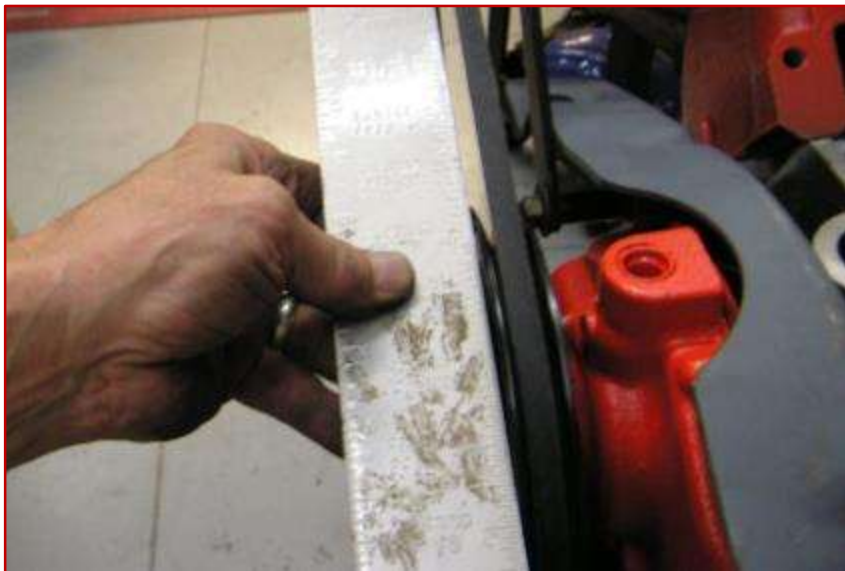
Checking alignment again with the reversed bushings.

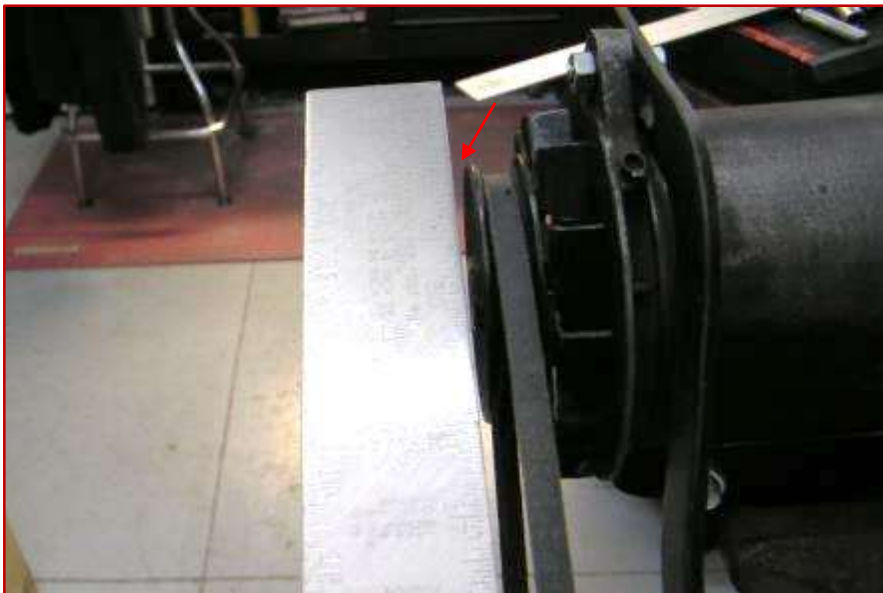
It's still too far rearward. This pulley will not work.

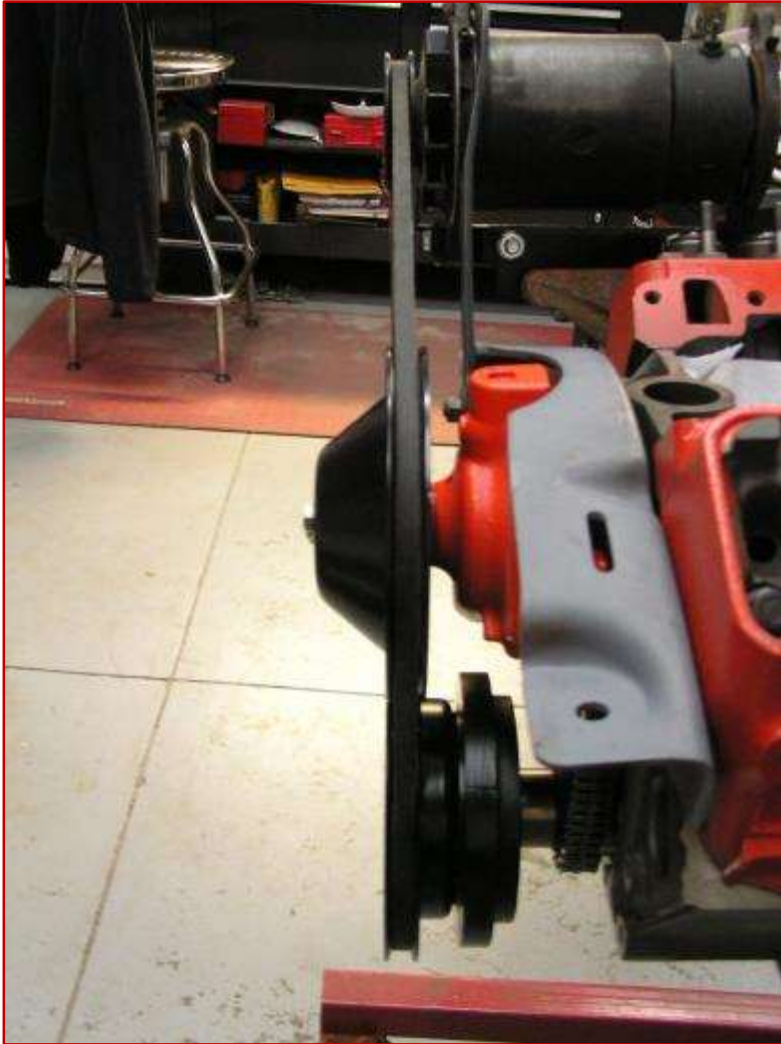
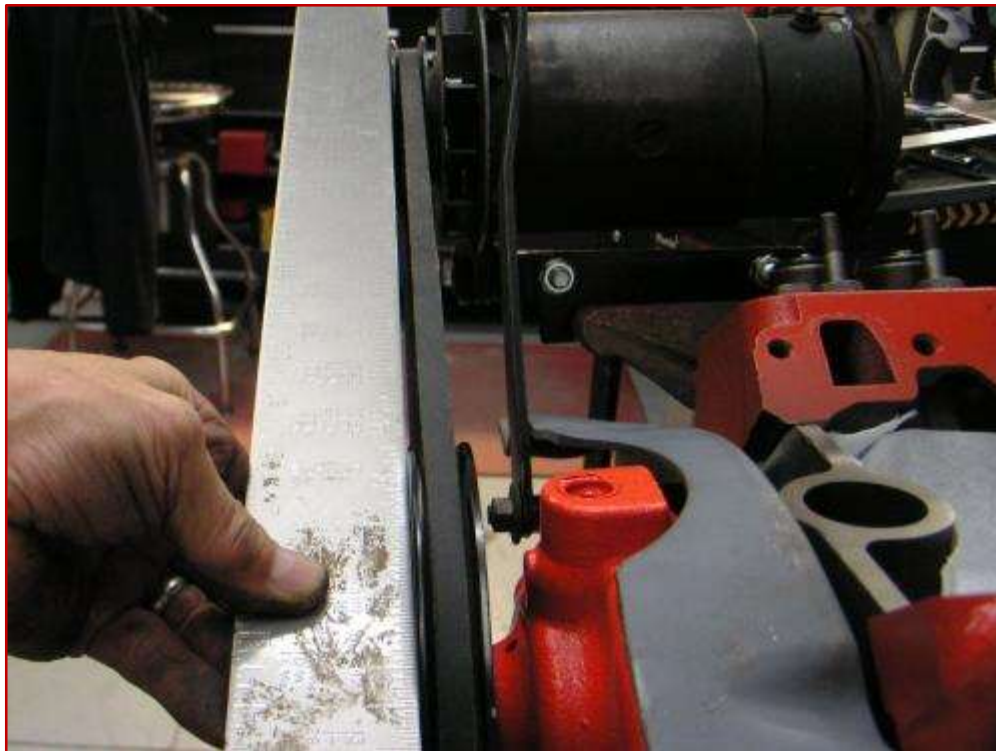
Here I have I reinstalled the offset pulley. With the rubber bushings reversed, the alignment is closer to the WP pulley.

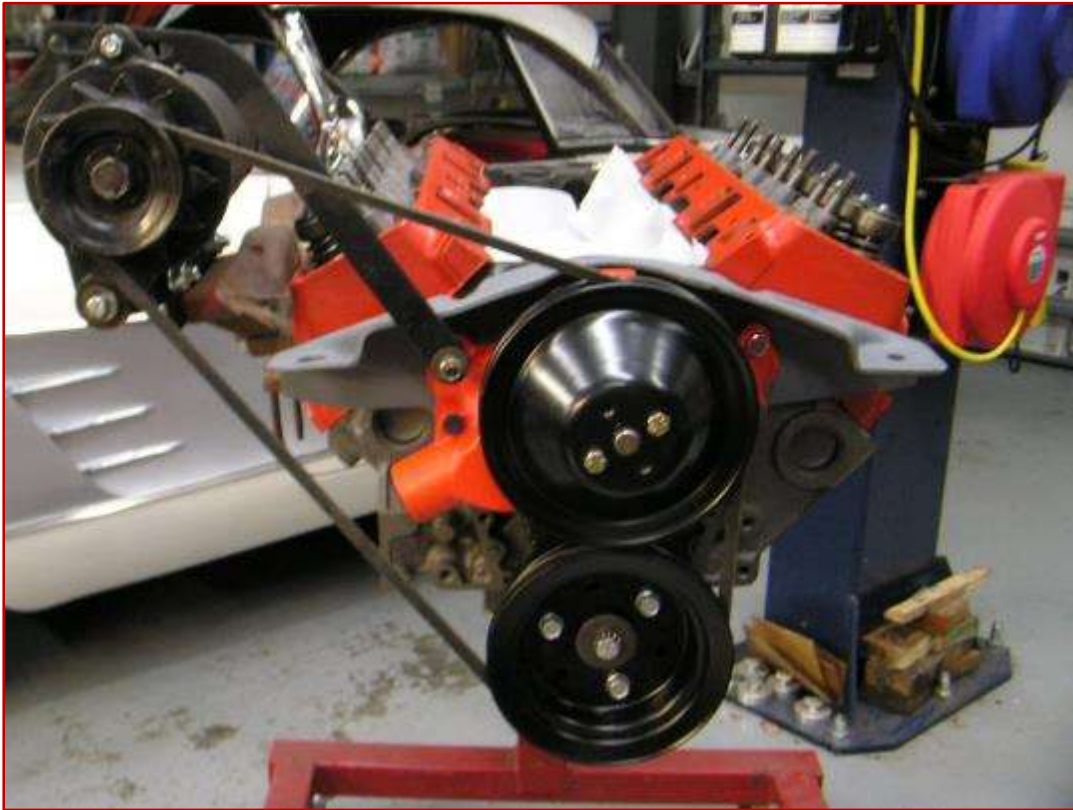
Once all of the correct pulleys and brackets are installed, slight adjustments can be made at other mount points to get the ideal pulley and drive belt alignment.

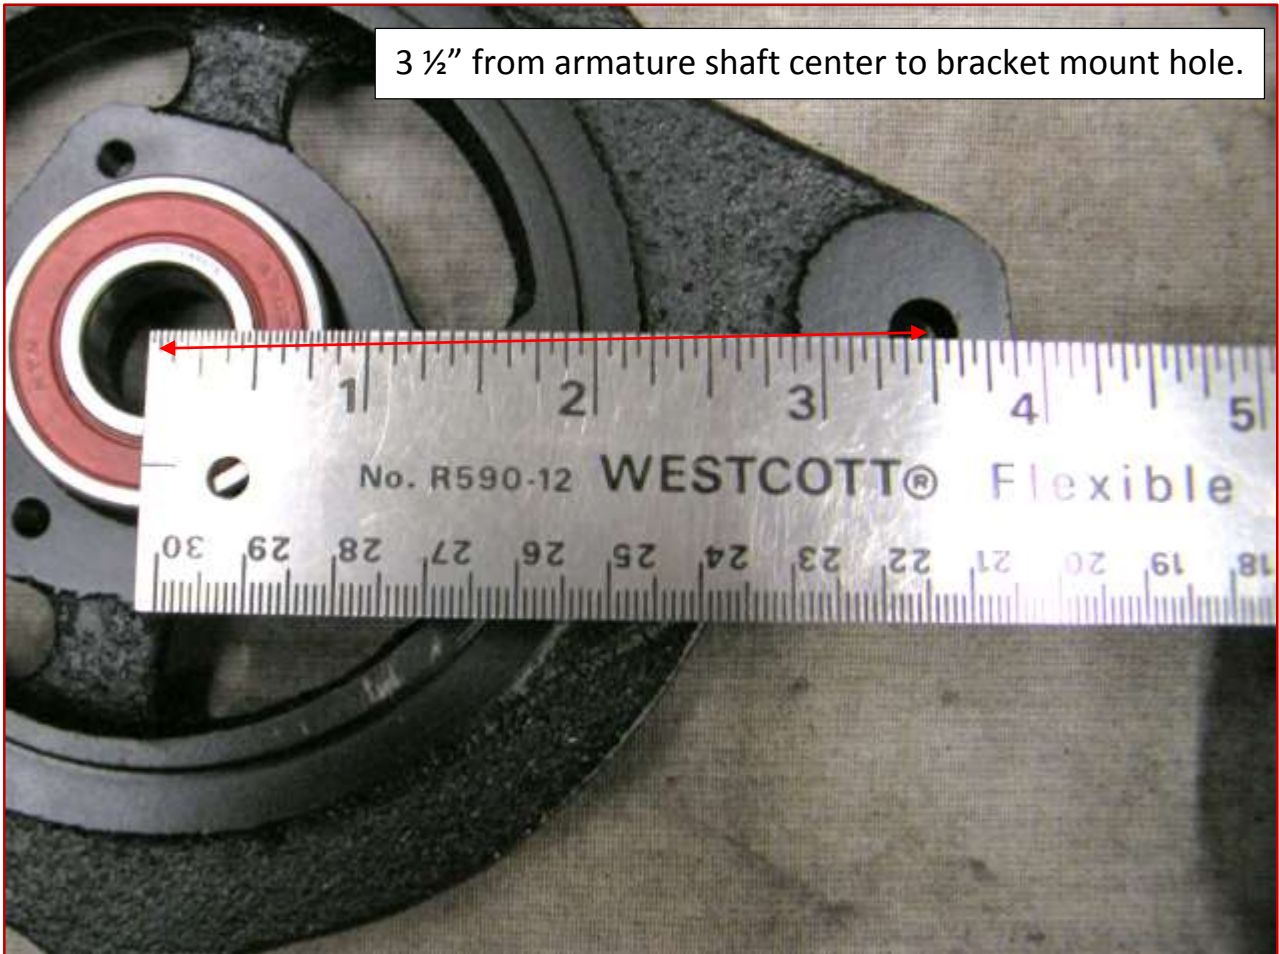
3 1/2" from armature shaft center to bracket mount hole.

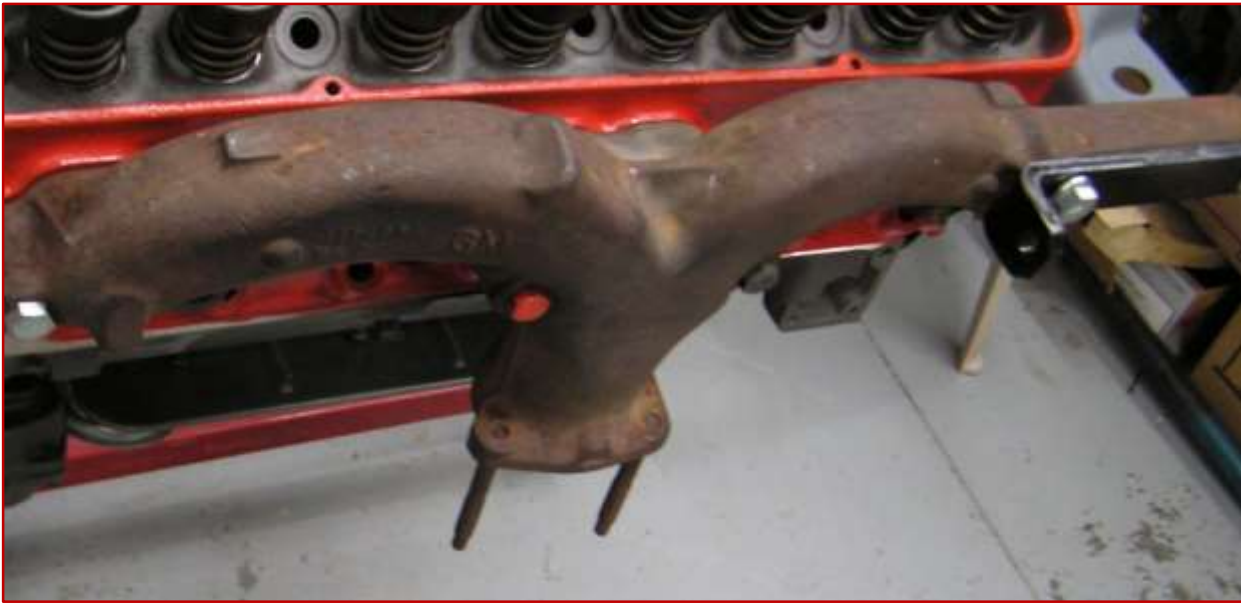
This is the FI exhaust manifold, note the **absence of the access hole** for a fresh-air carburetor choke tube.

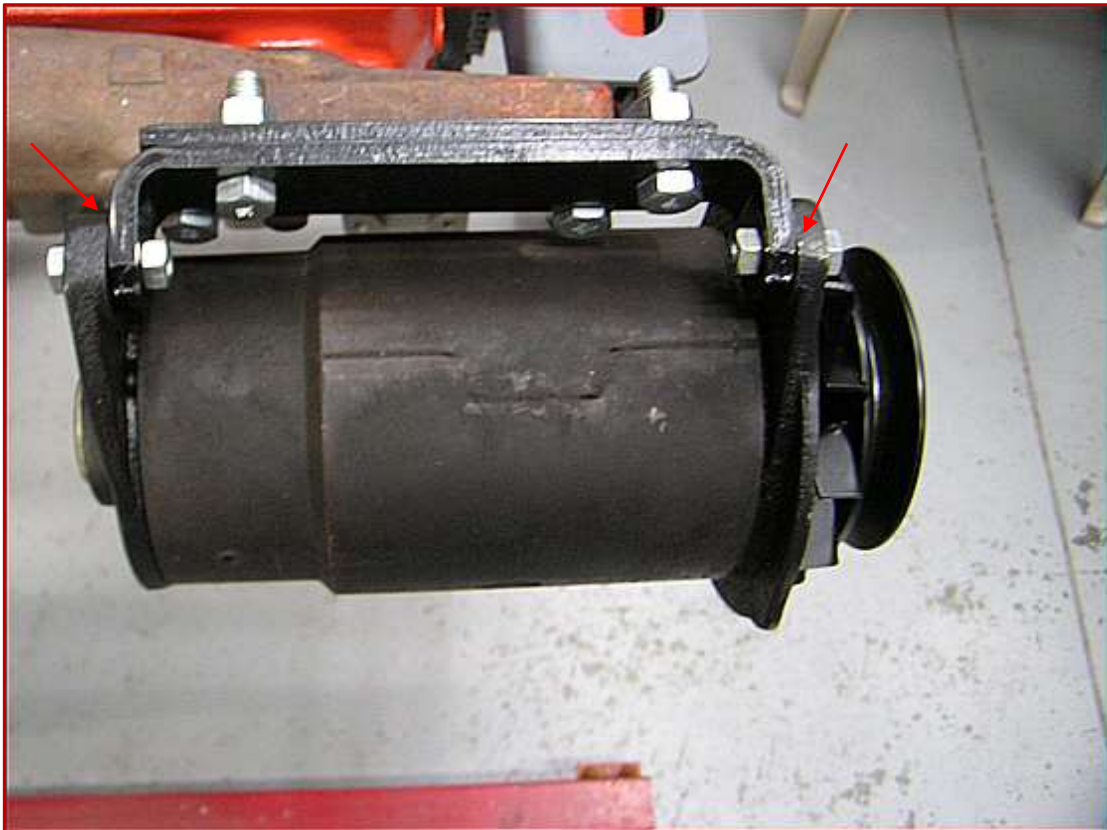
Here the generator is mounted showing the U-Bracket. Note the solid mounts.

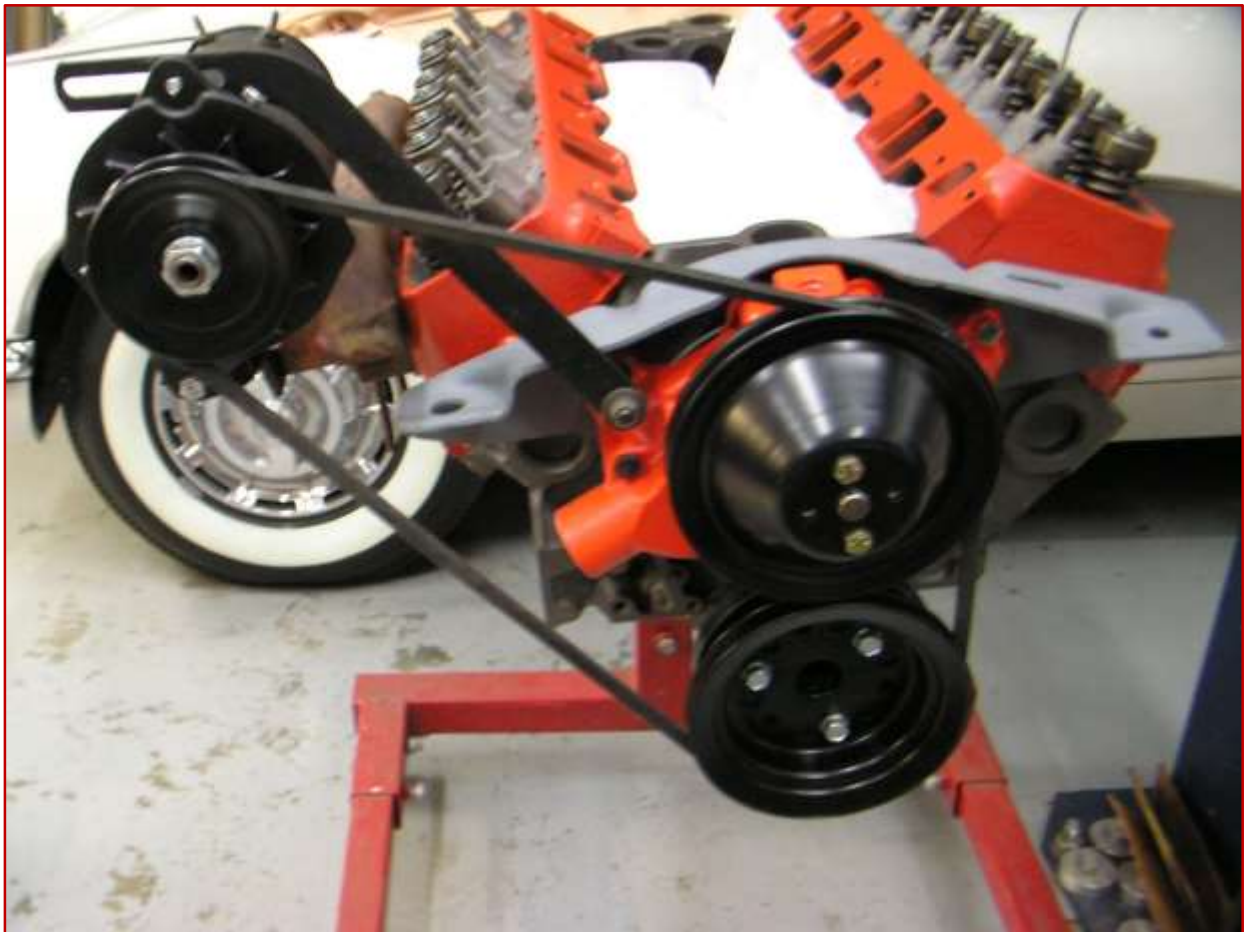
When first attached, alignment was off about 1/8"....

....as seen more closely here.

By loosening all bracket bolts, as well as the exhaust manifold bolts, and then pulling everything more forward before re-tightening, I'm able to bring the alignment in to near perfect.

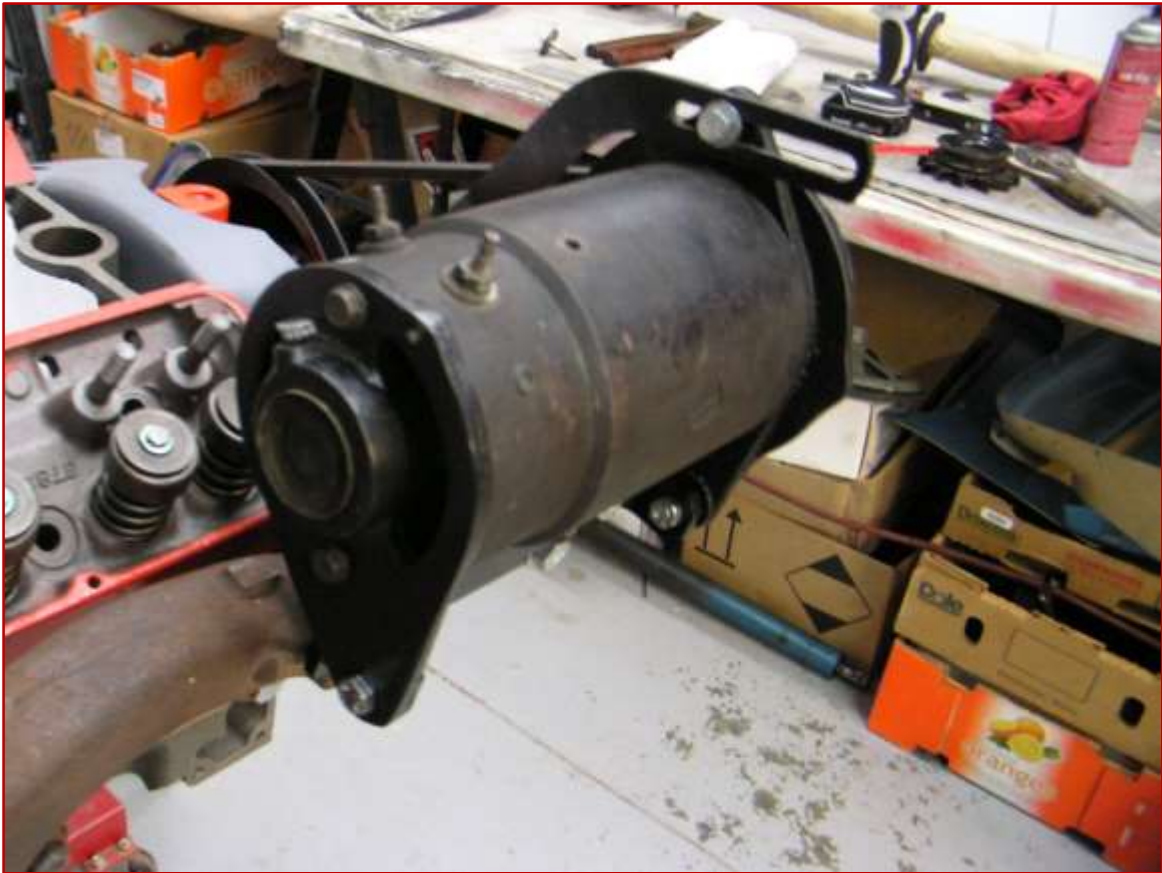
Here is the result of making minor adjustment to all generator mount points.

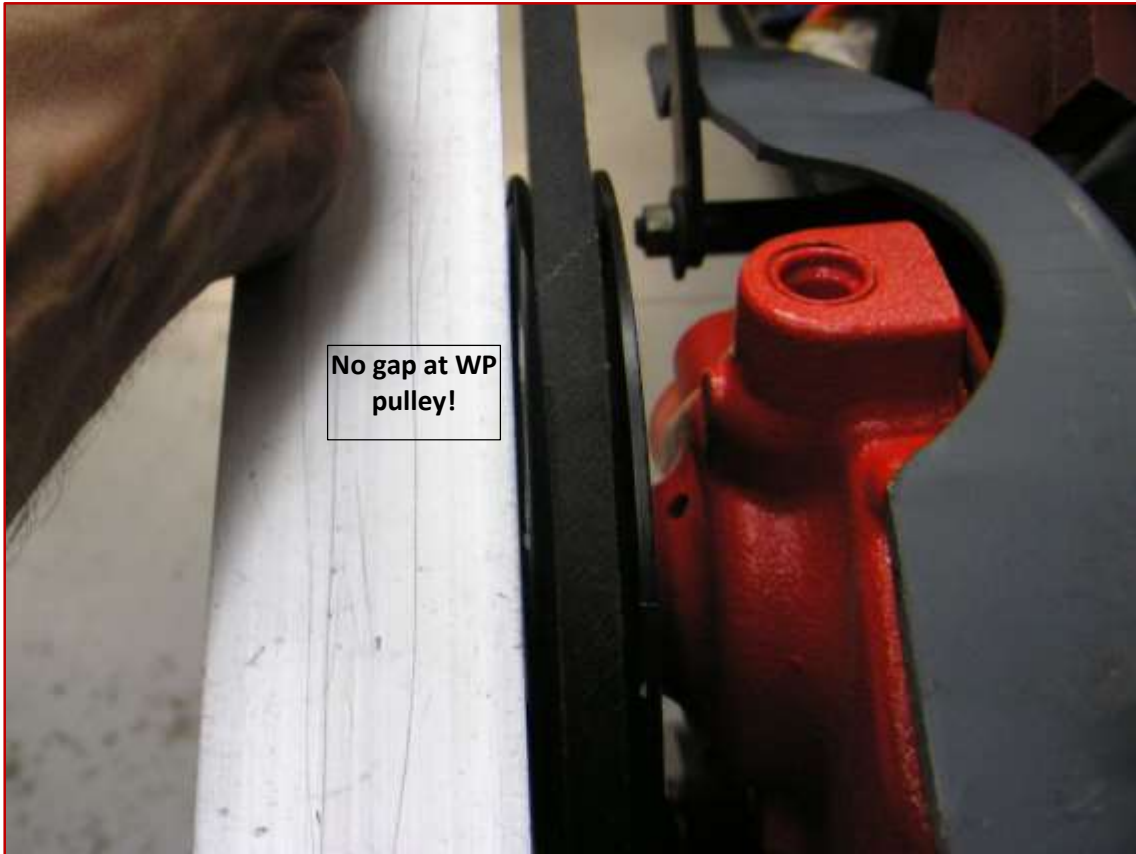
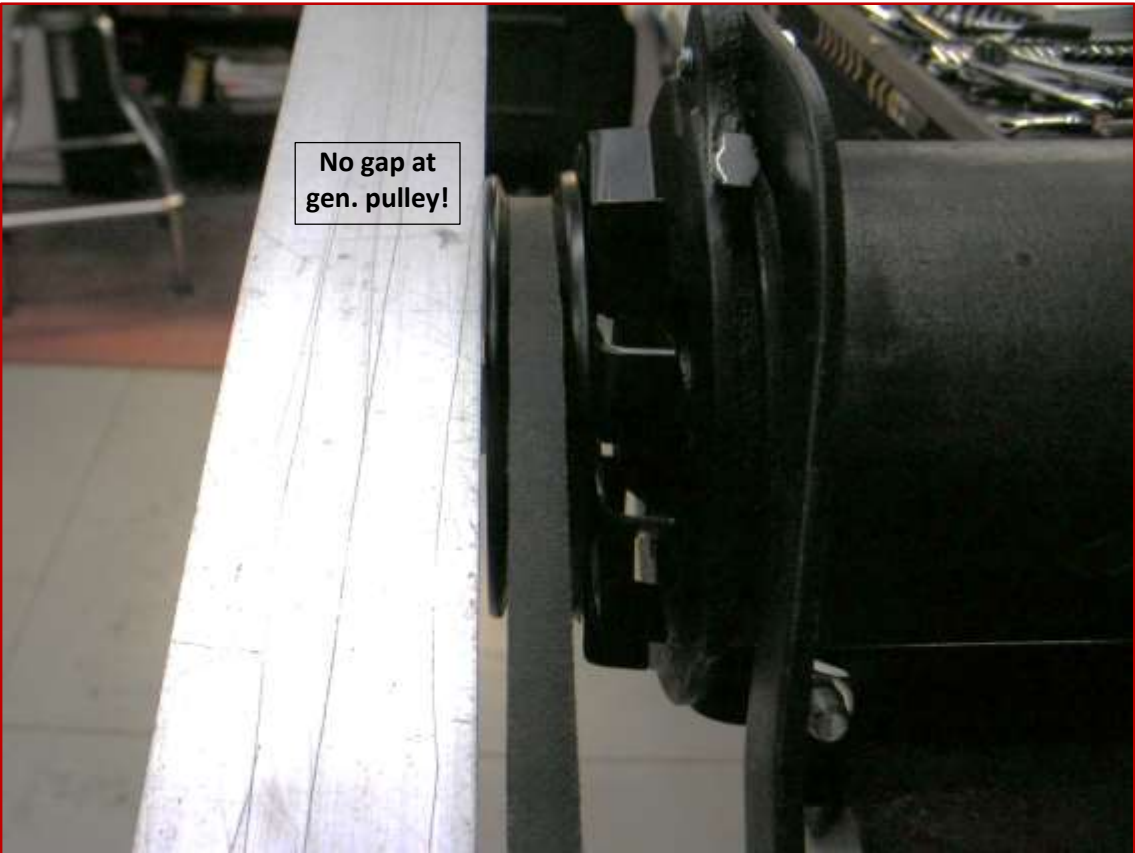
No gap at WP pulley!

This is proper generator alignment.

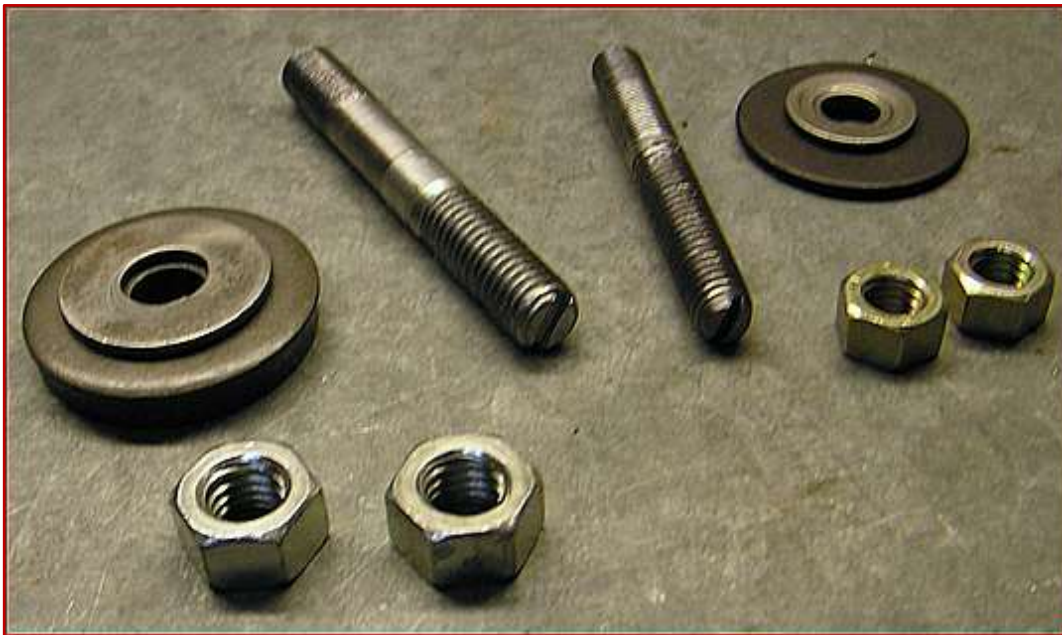
These are my home-made "Pullers". Simply thread the stud into the crankshaft **until seated**, install the HB and using a nut on the forward end, pull (or should I say "push") the HB over the crank. The large one below is 7/16"-20 & 7/16"-14 on the "nutted" end. The smaller one I had to make for a different car which had 3/8" threads in the crankshaft and a safety-wired wired bolt on a '56 race-car.

Rather than using the HB attaching bolt, you can use a "puller" (see below) to install the HB onto the crankshaft. If not available, acquire a threaded Grade 5 bolt 7/16"-20 about 3" long, cut the head off, then using a thread die, thread it to the appropriate size at the cutoff end. You can use *coarse thread* there.

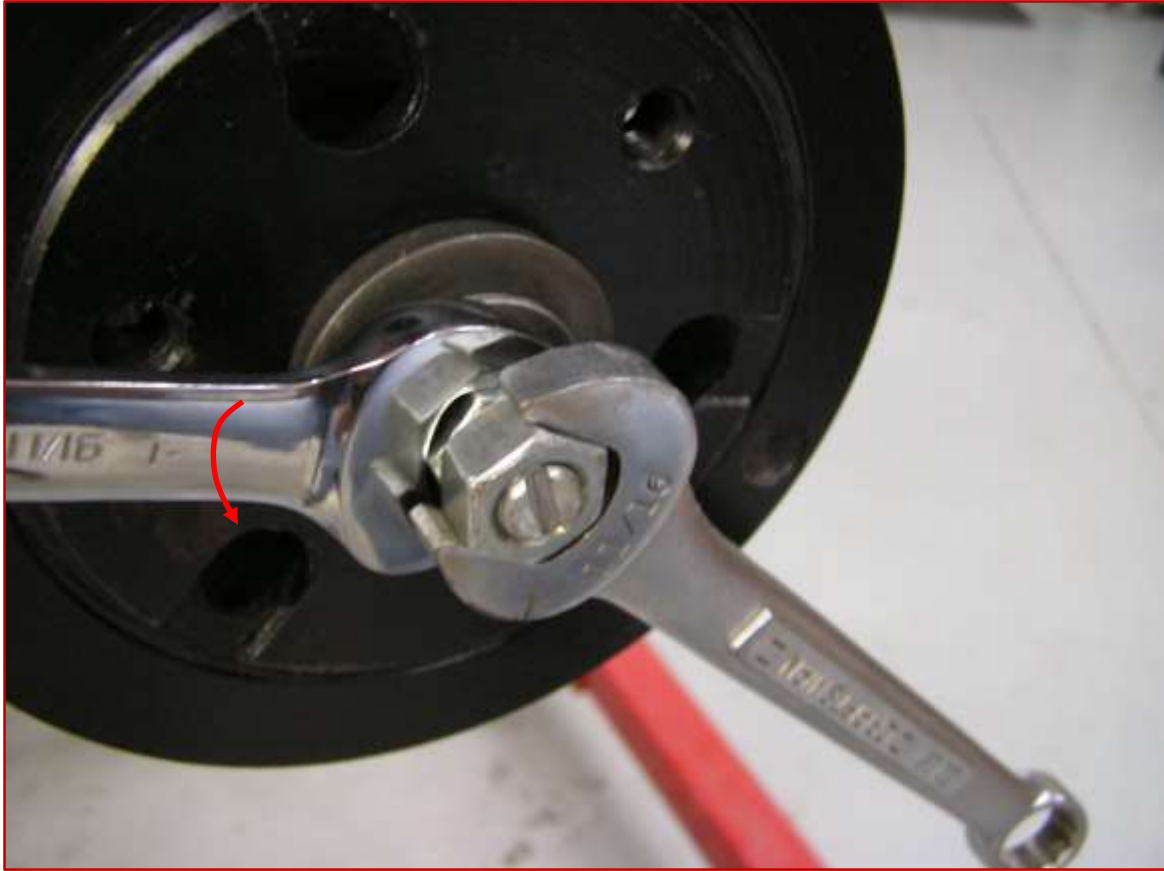
To remove your puller you may need to “double nut” it and remove it by turning the inner nut CCW to back it out as shown below.

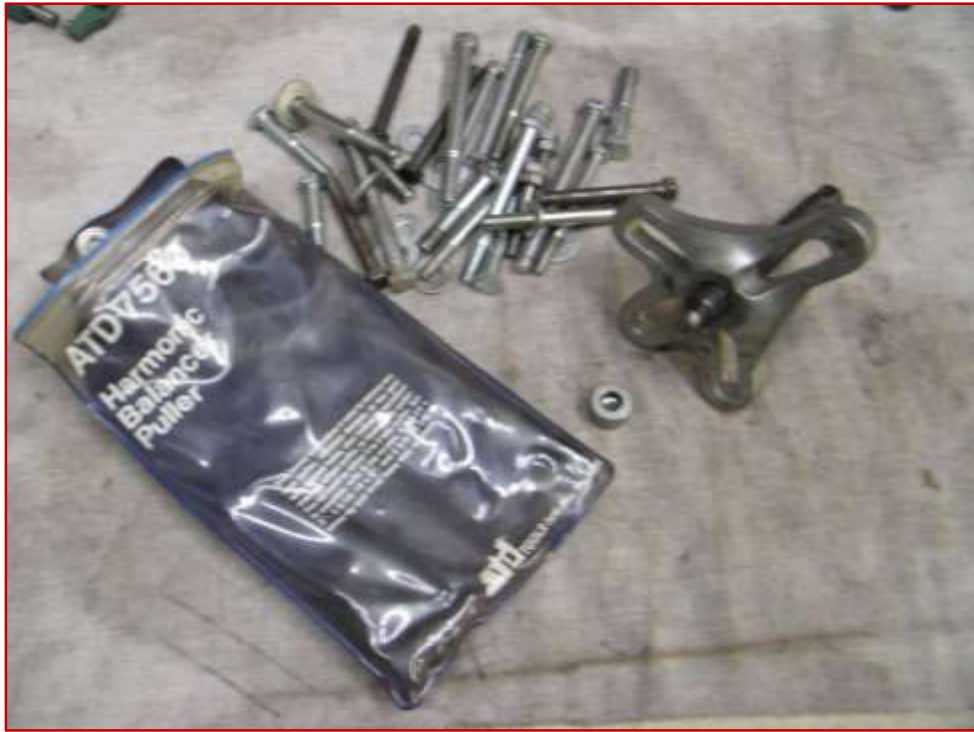
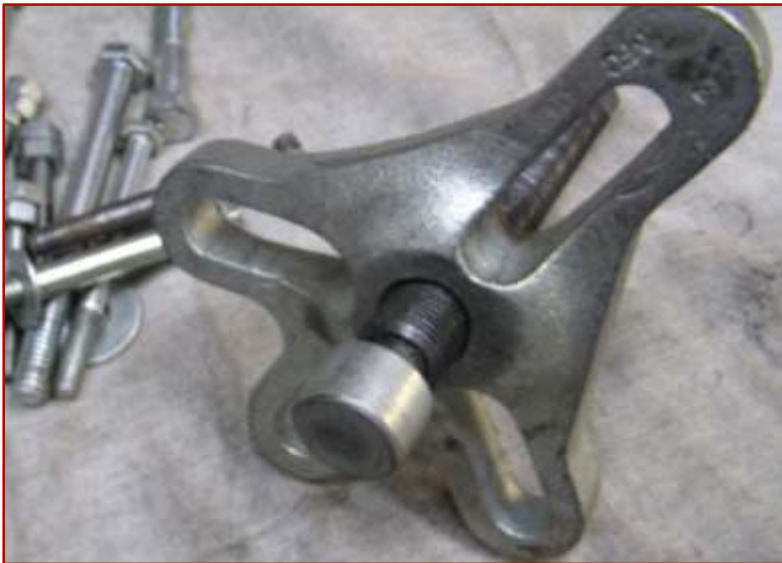
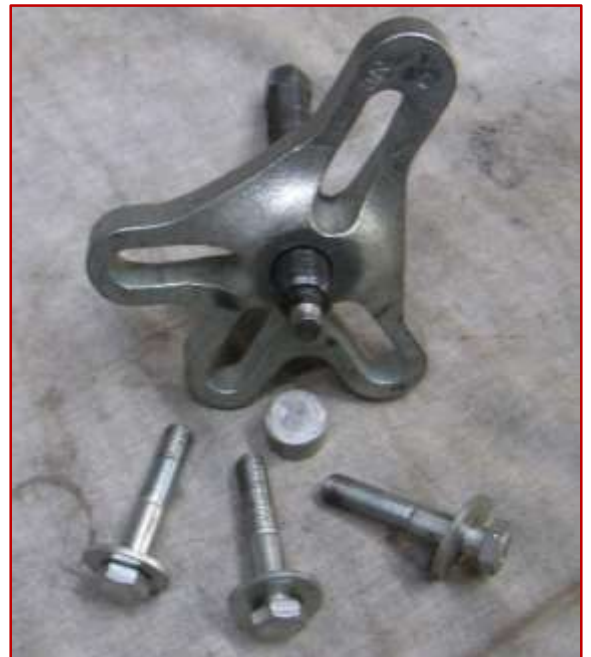
To remove the balancer, use an HB Puller. This one can also be used as a steering wheel puller.

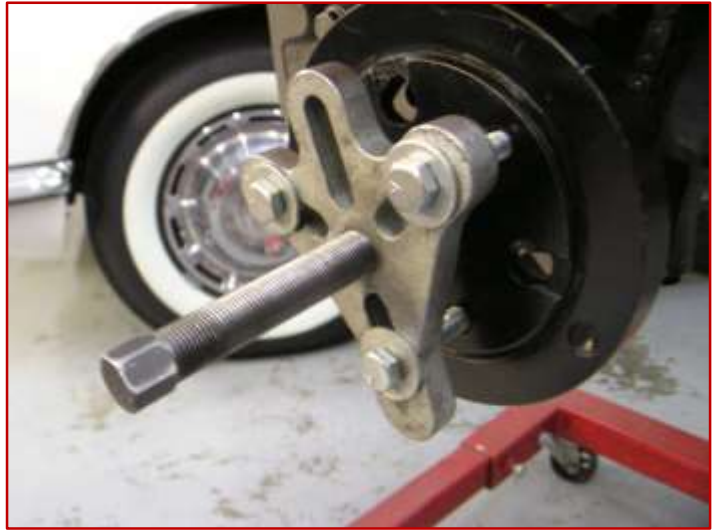
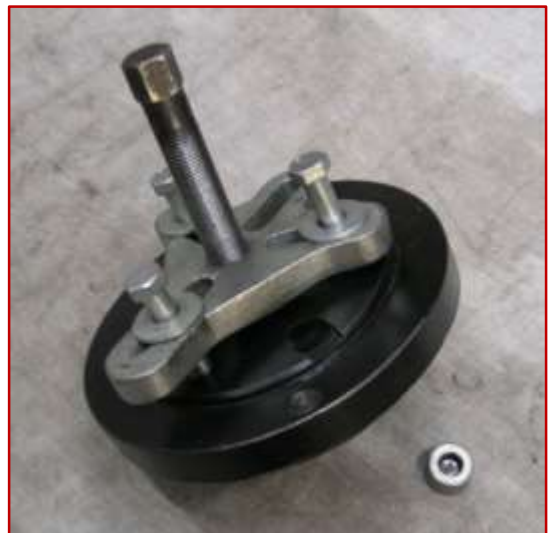
Attach the HB puller to the HB using the bolts with appropriate threads for the holes (circled below) in the balancer. Make sure the "swivel" tip is in place.
